Corrosion and Corrosion Mitigation in Fire Protection Systems

Paul Su and David B. Fuller

FM Global
1151 Boston-Providence Turnpike
Norwood, MA 02062

2nd Edition, July 2014

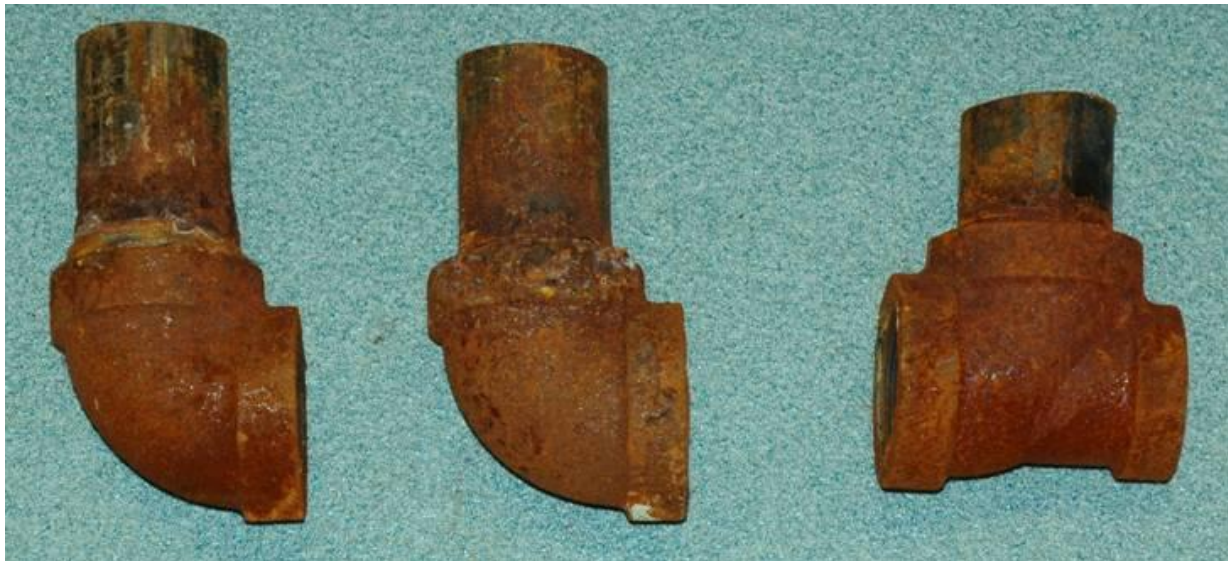
Figure 4.2 Uniform corrosion of steel sprinkler pipe joints (2 inch dia.) in a wet pipe system caused by water leakage past their thread joints.

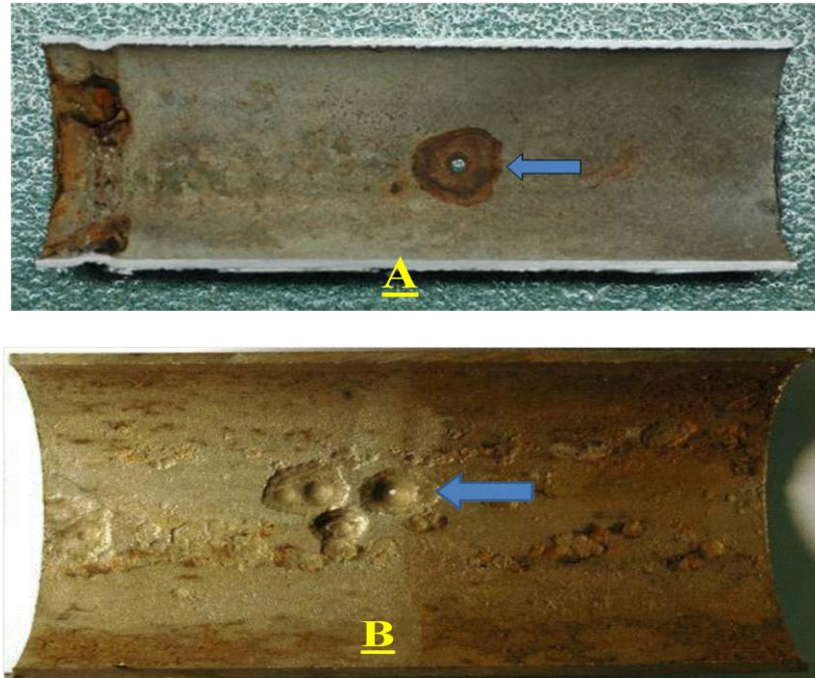
Figure 4.5 (A) Through-wall leakage of pitting at the bottom of a NPS 3 (3.5 inch OD) galvanvanized steel sprinkler pipe in a dry pipe system. (B) Through-wall leakage of pitting at the bottom of a NPS 3 black steel sprinkler pipe in a wet pipe system.

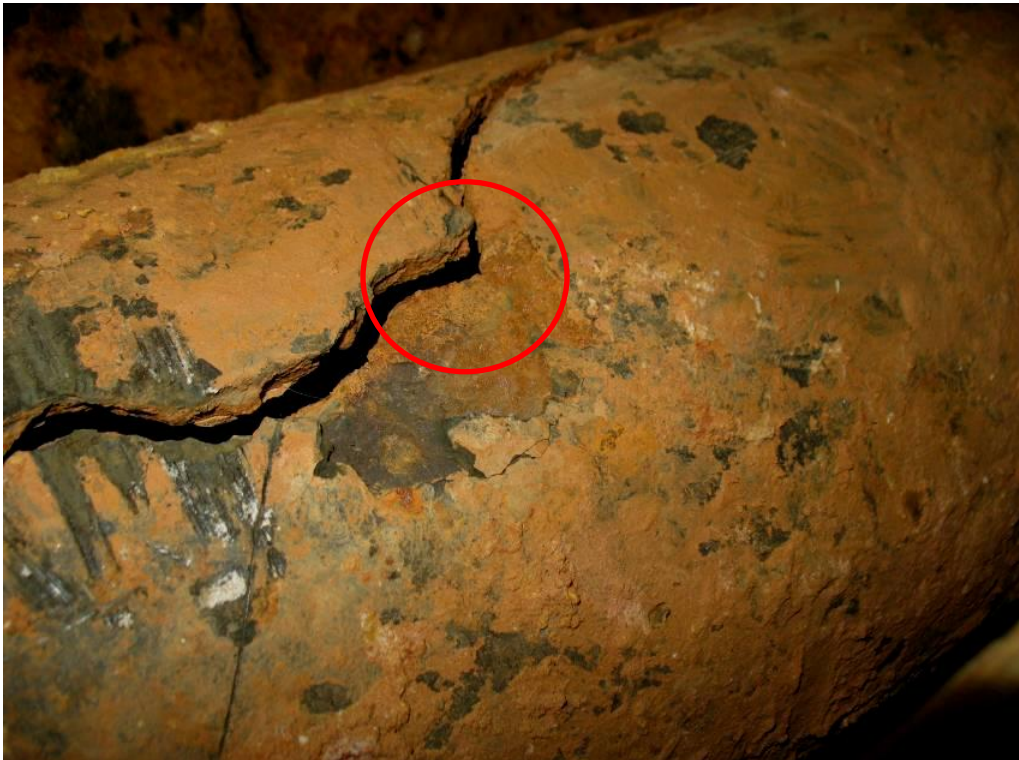
Figure 4.7 shows a ruptured underground water main (identified as gray cast iron, 8-inch diameter) with cement lining on the main's inside diameter. The circled area in Figure 4.7 exhibits graphitic corrosion on the outside surface of the main due to its exposure to mildly aggressive groundwater and soils. Generally, high moisture content in the surrounding soil is required for graphitic corrosion to occur.

Figure 4.7 Photograph showing a ruptured underground water main (8 inch dia.) with circled area indicative of graphitic corrosion.

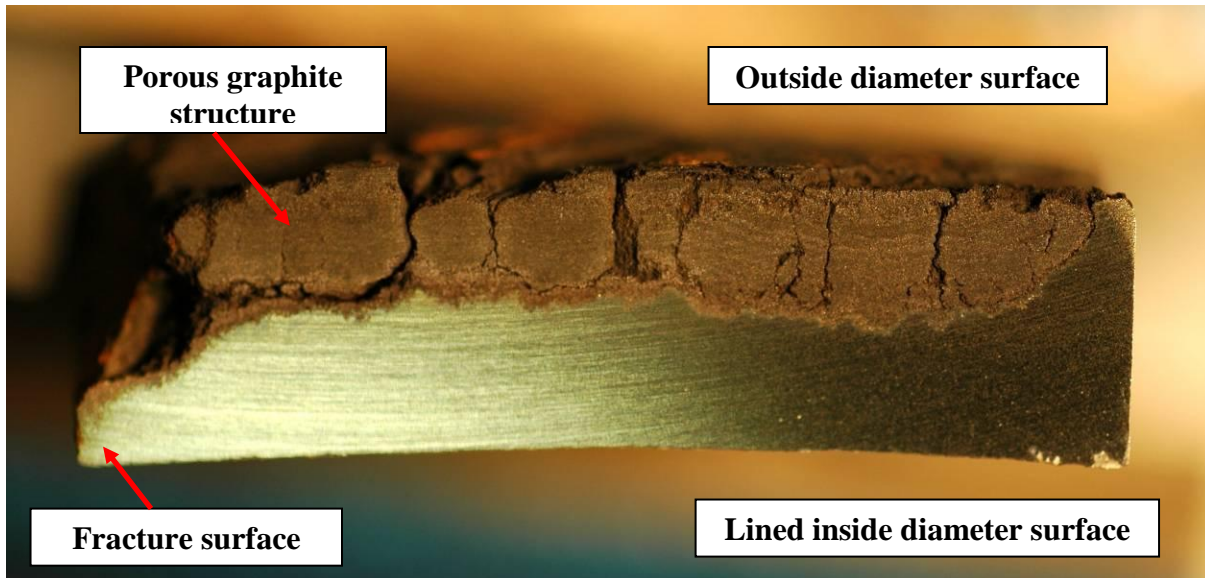
Figure 4.8 Photograph showing the cross section for part of the water main in Figure 4.7. Almost the entire wall thickness of the pipe has been penetrated by graphitic corrosion attack at the far left fracture face.

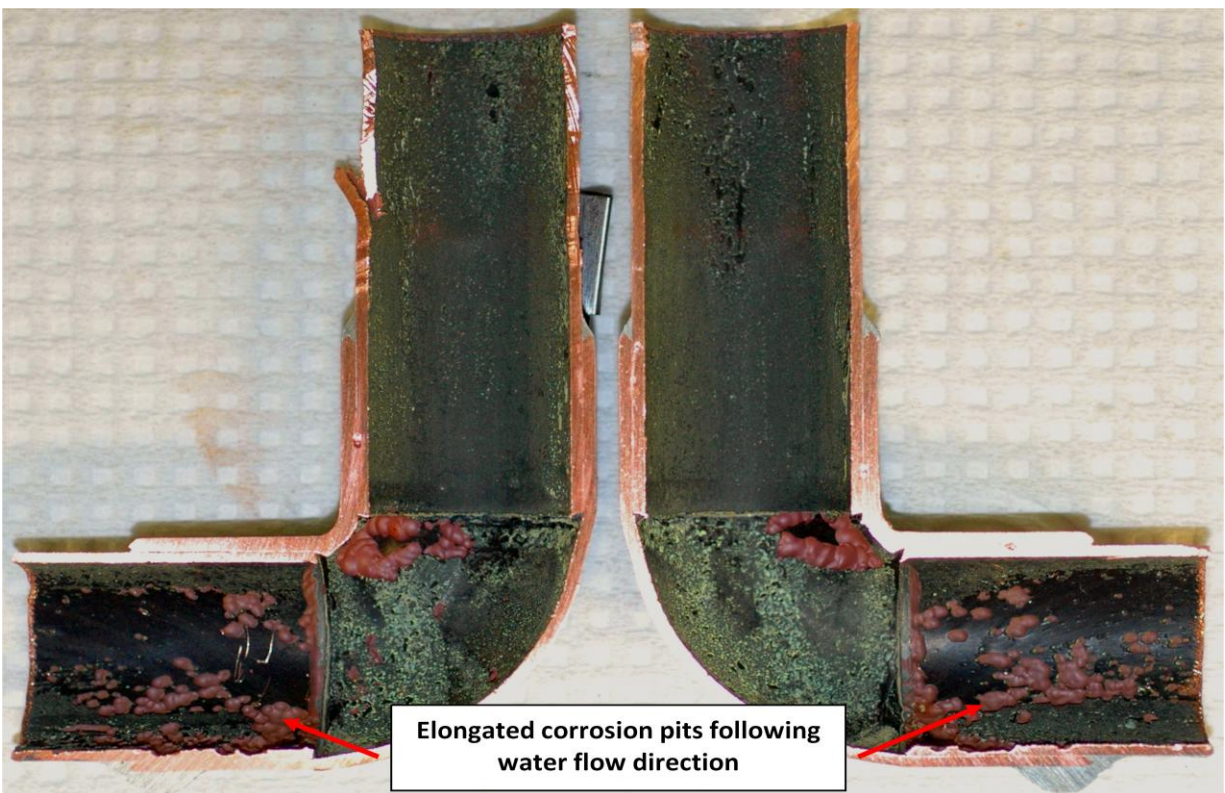
The black and greenish materials shown in Figure 4.9 are different forms of copper corrosion products, such as cupric oxide (CuO , black), cuprous oxide (Cu_2O , reddish-brown), and malachite [$\text{Cu}_2(\text{CO}_3)(\text{OH})_2$, blackish green].²³ It should be noted that corrosion of copper piping in FPS can be caused by aggressive water quality/chemistry parameters²³, such as sprinkler water with pH values ranging from 7.0 to 7.7, stagnant water with air pocket supplying dissolved carbon dioxide (CO_2) and oxygen (O_2), dissolved anions (chloride and sulfate), low alkalinity and by residual soldering flux during fabrication of copper pipe joints.^{24,25}

Figure 4.9 Photograph showing erosion corrosion (elongated corrosion pits following water flow direction) in a copper domestic water line.

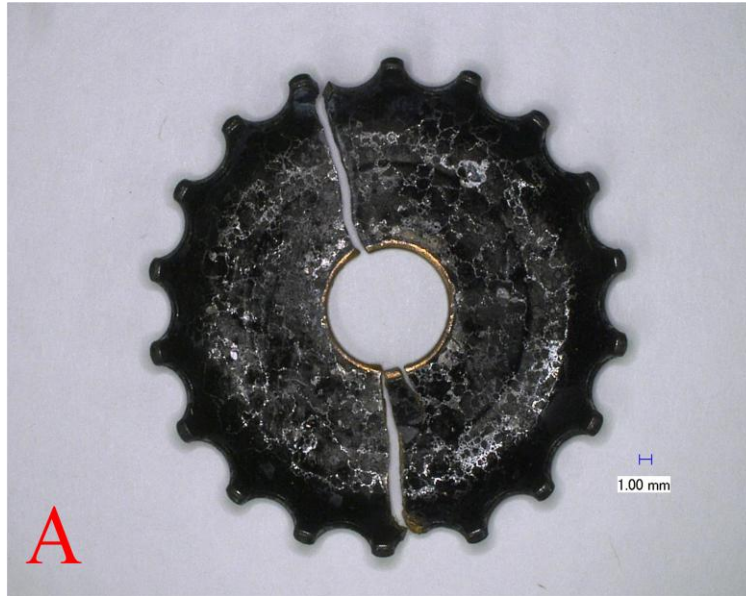
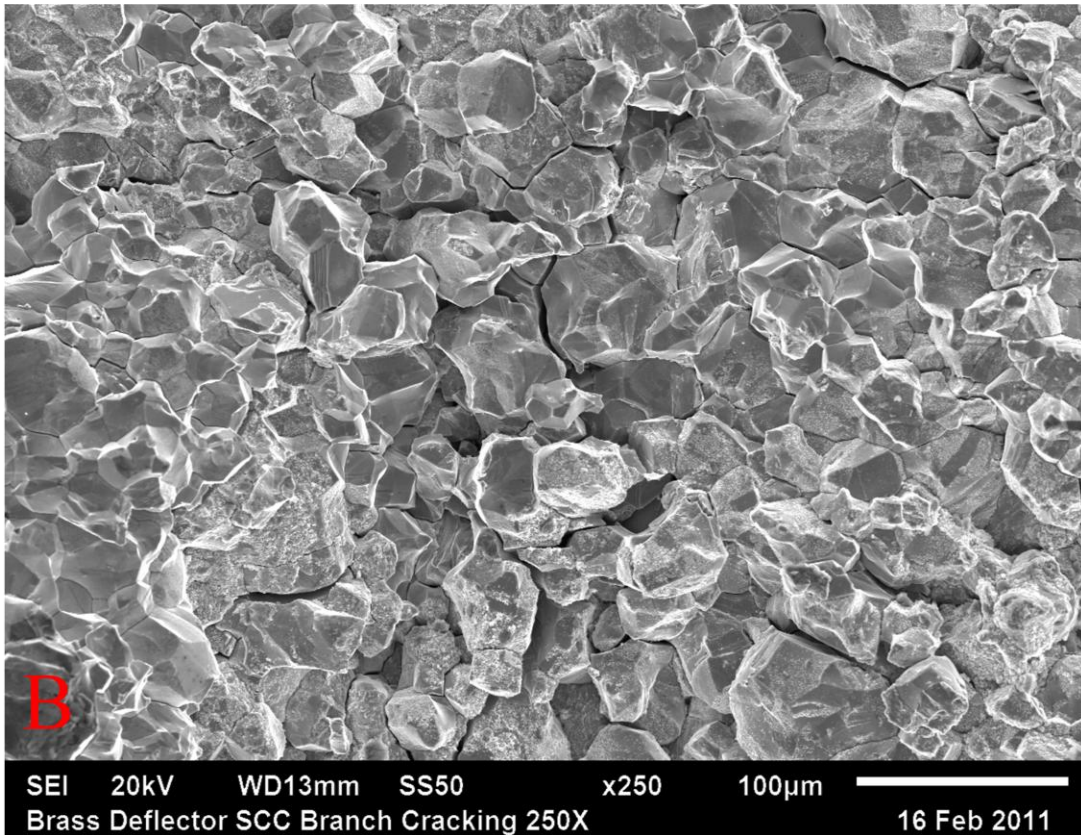
Figure 4.10 (A) Photograph showing SCC failure across the deflector of a brass sprinkler after the ammonia SCC testing. (B) SEM photograph of cracking morphology for fracture surface on the deflector in Figure 4.10 (A).

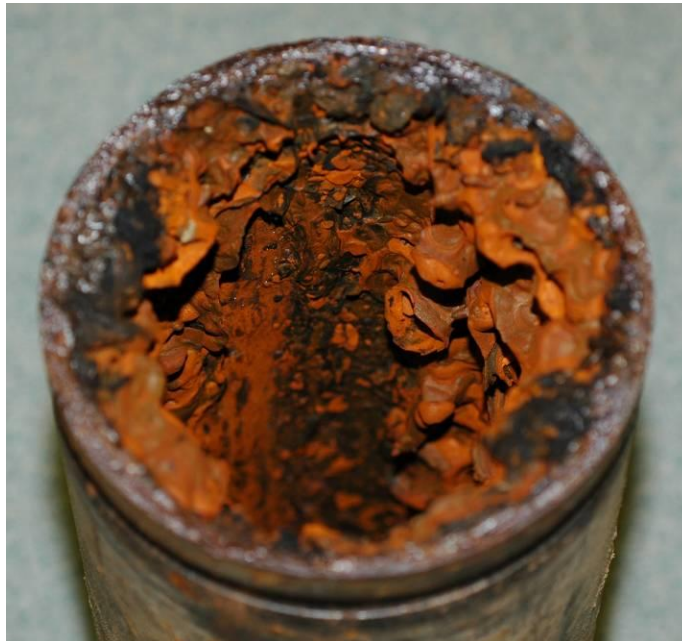
Figure 4.15 Photograph showing a corroded/leaked steel sprinkler pipe (4 inch dia.) with many tubercles. MIC caused by SRB was identified to be a likely contributing factor to pipe corrosion.

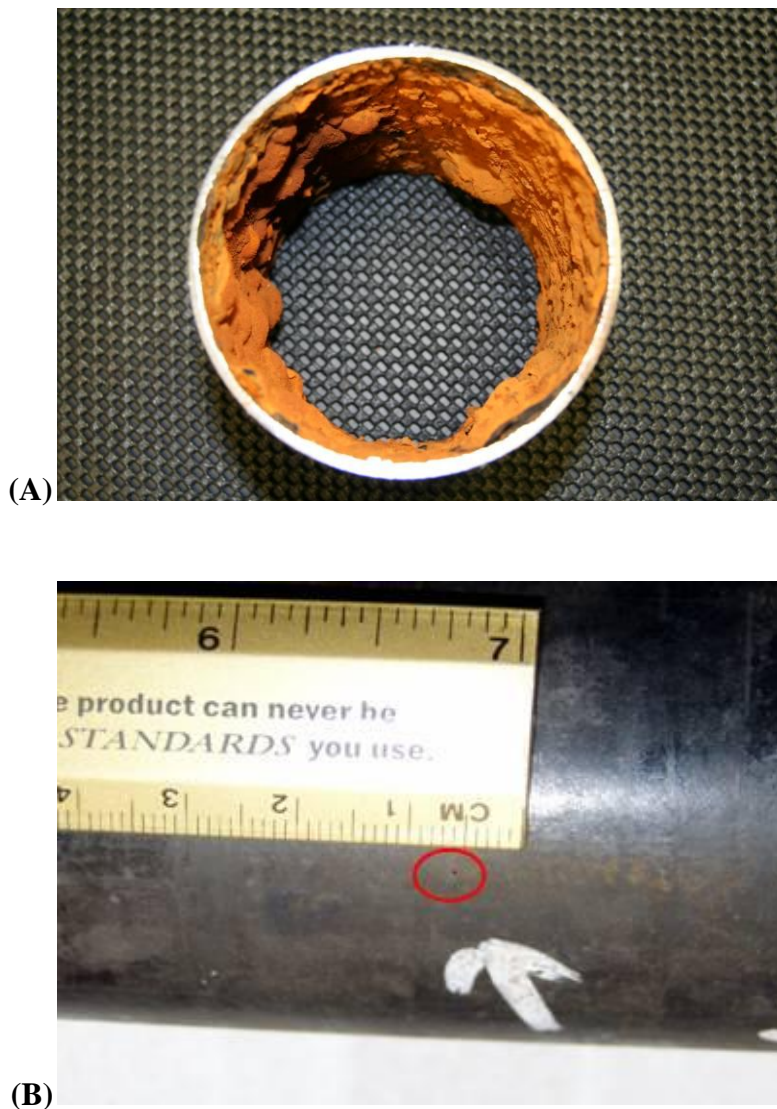
Figure 4.16 Photograph showing tubercles and pinhole (circled) leakage of steel sprinkler pipe in wet pipe systems. (A) Tubercles heavily formed inside a steel sprinkler pipe (4 inch dia.). (B) Pinhole (circled) leakage on a steel sprinkler pipe.

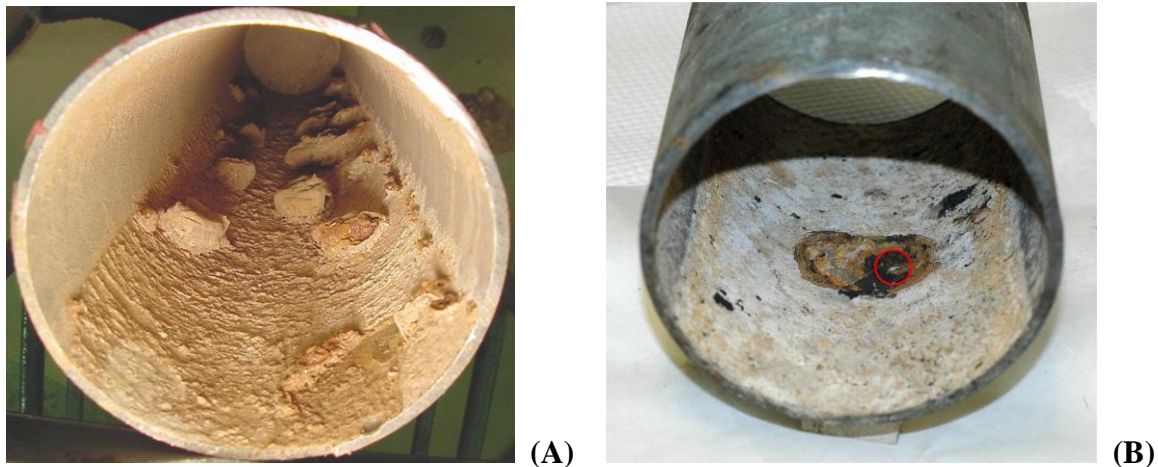
Figure 4.17 (A and B) shows tubercles and pinhole (circled) leakage of galvanized steel sprinkler pipe in dry pipe systems. Tubercles heavily formed inside a galvanized steel sprinkler pipe (4 inch dia.) are seen in Figure 4.17 (A); corrosion products such as white zinc oxide (ZnO) and zinc hydroxide ($\text{Zn}(\text{OH})_2$) cover non-tubercle surfaces. Figure 4.17 (B) shows corrosion at the base of a tubercle, which ultimately led to the observed through-wall leakage.

Figure 4.17 Photograph showing tubercles and pinhole (circled) leakage of galvanized steel sprinkler pipe in dry pipe systems. (A) Tubercles heavily formed inside a galvanized steel pipe (4 inch dia.). (B) Through-wall (circled) leakage underneath a tubercle (removed) on a galvanized steel pipe.

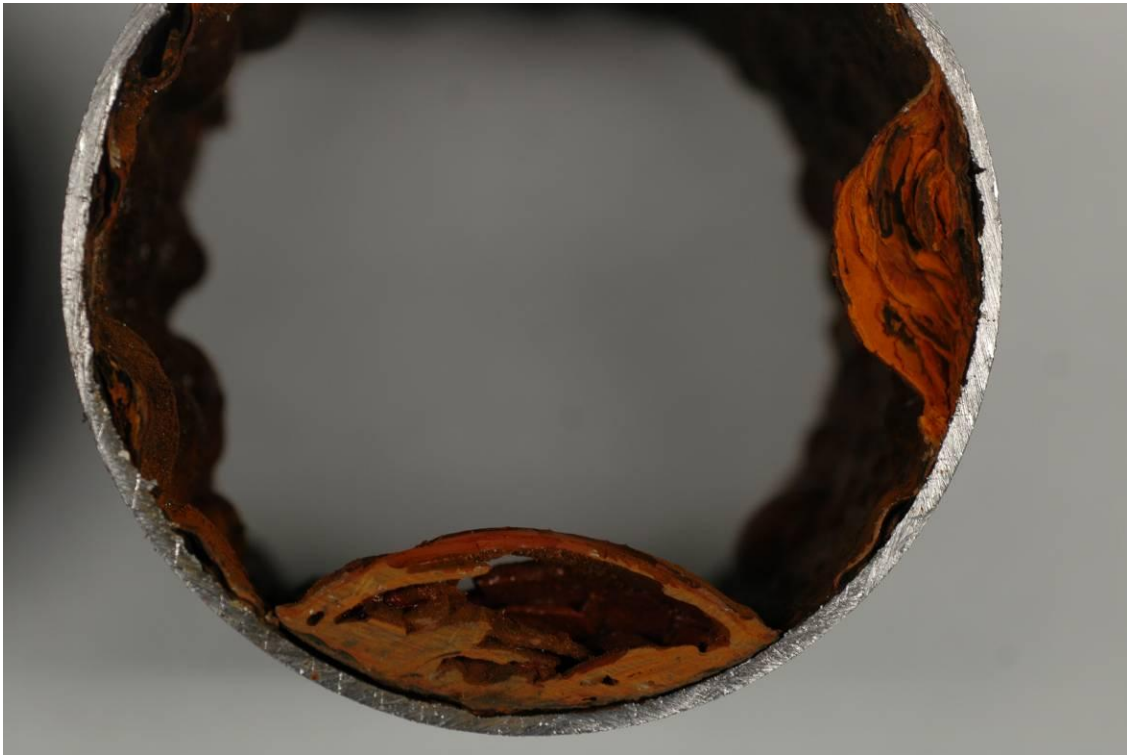
Figure 4.19 shows the cross section of several non-MIC tubercles in a NPS 4 Schedule 10 steel sprinkler pipe. Irregular shapes of cavities are visible inside two larger tubercles. The orange and brown-like layers of corrosion product are likely to be hydrated iron(III) oxides $\text{Fe}_2\text{O}_3 \cdot n\text{H}_2\text{O}$ and iron(III) oxide-hydroxide ($\text{FeO}(\text{OH})$) and the black layers of material could be magnetite (Fe_3O_4). In this case, intermittently charging oxygenated water into the system may have created oxygen concentration cells and changed the local water chemistry in the steel pipe, resulting in promoting the growth of tubercles.

Figure 4.19 Photograph showing the cross section of non-MIC tubercles in a NPS 4 Schedule 10 steel sprinkler pipe. Irregular shapes of cavities are visible inside two larger tubercles.

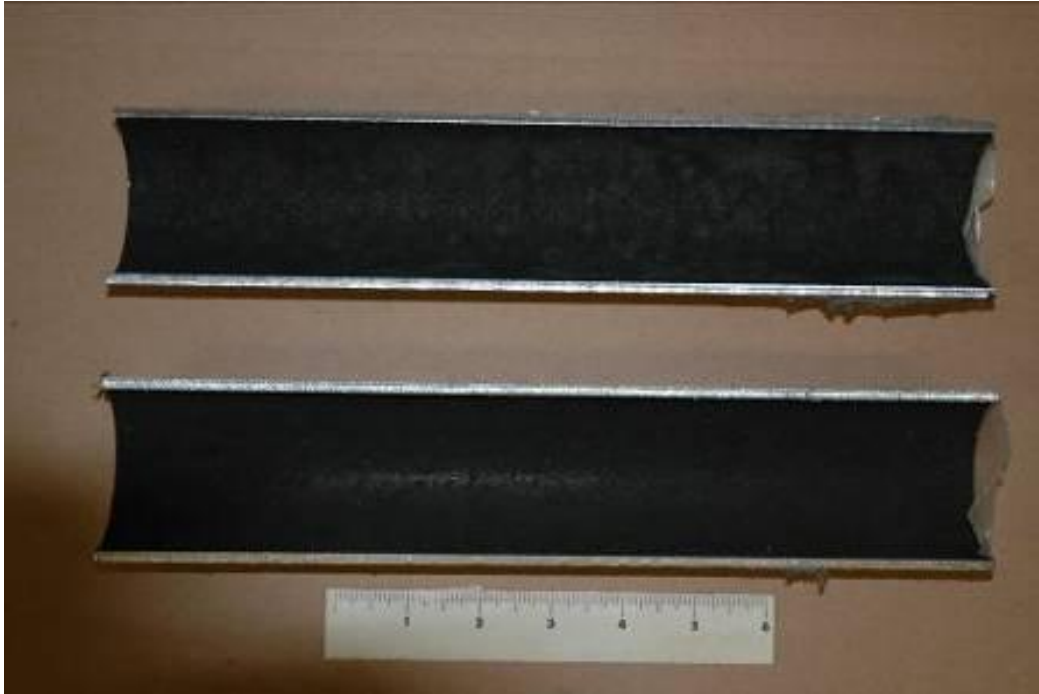
Figure 4.20 shows steel pipe in a wet pipe system with limited corrosion forming a layer of black magnetite (Fe₃O₄) on its internal pipe surface. This magnetite layer was created when oxygen in the initial aerated water reacted with the steel pipe and was depleted. Limiting the oxygen supply and reducing its concentration in FPS can substantially mitigate corrosion.

Figure 4.20 Photograph showing steel pipe in a wet pipe system with limited corrosion after forming a layer of black magnetite and depleting oxygen inside this piping system.

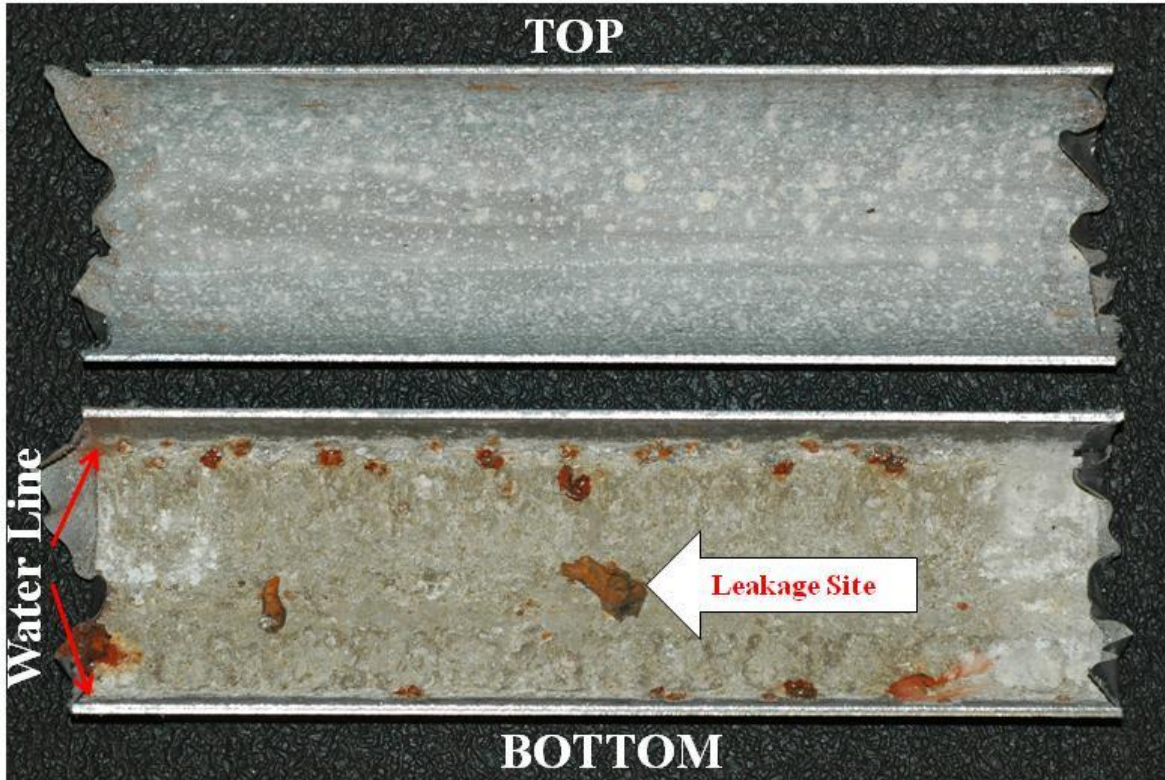
Figure 4.21 Photograph showing NPS 4 galvanized steel pipe (4.5 inch OD) with a through-wall leakage. Residual water filled about 40% of the pipe's volume in service. Under the waterline, white rust and well over a dozen reddish-brown tubercles of various sizes are evident on the bottom half of the pipe.

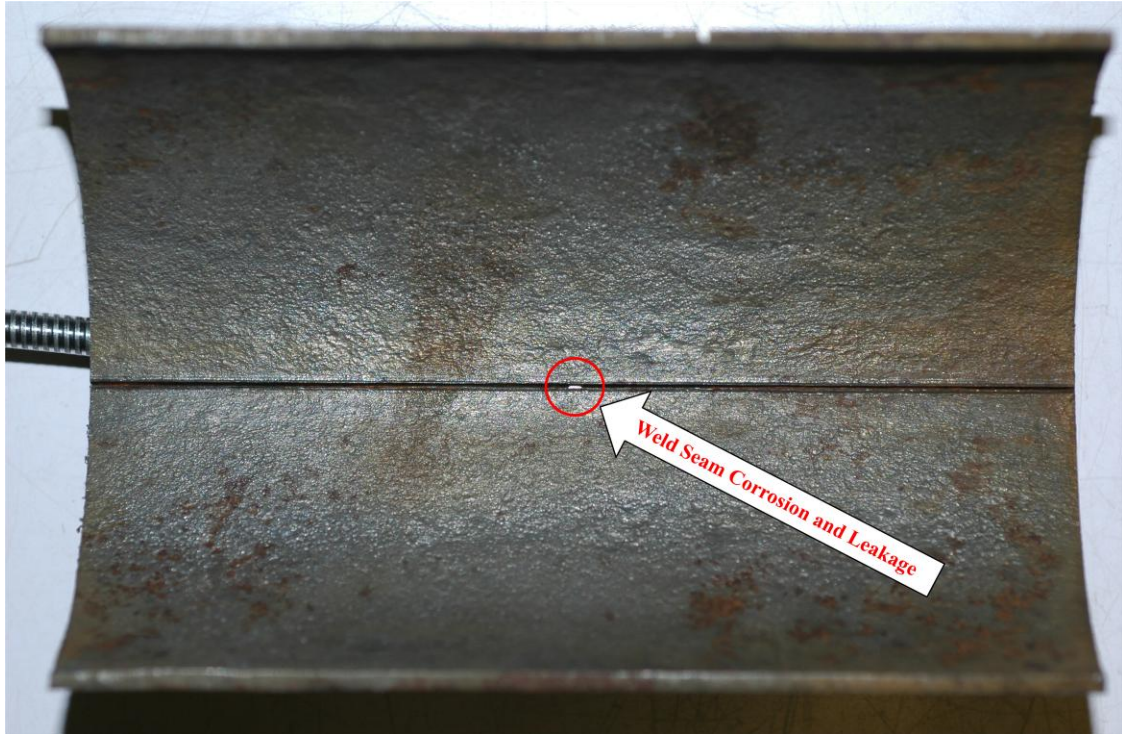
Figure 5.2 Photograph showing preferential grooving corrosion on pipe weld seam with a 1 mm pinhole leak in a wet pipe system, after removing corrosion products inside an NPS 3 pipe.

1. Orient longitudinal pipe weld seam toward building roof - at least 45° in relationship to the floor (for reference, the weld line points at the floor at 0°) to mitigate pipe weld seam corrosion in the FPS.

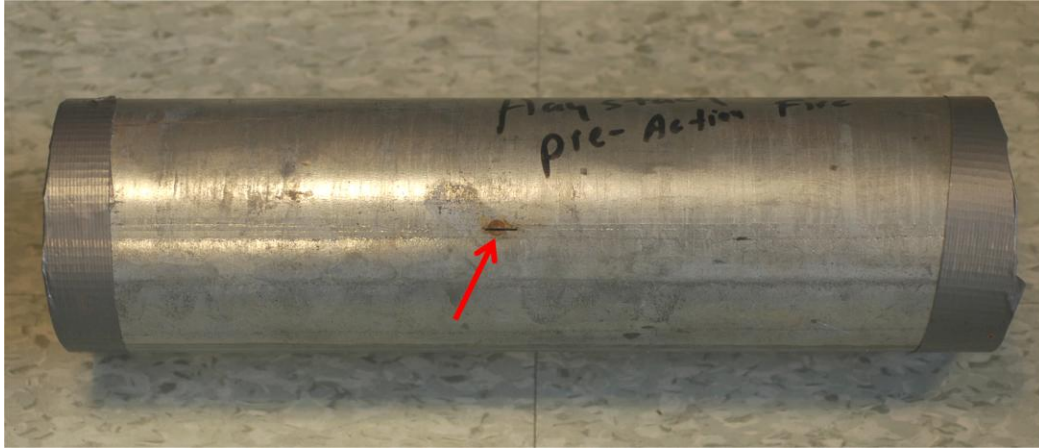
Figure 5.3 Photograph showing the outside of the bottom half of the pipe in Figure 4.21. The arrow points a longitudinal through-wall leakage site on the pipe in a preaction system.

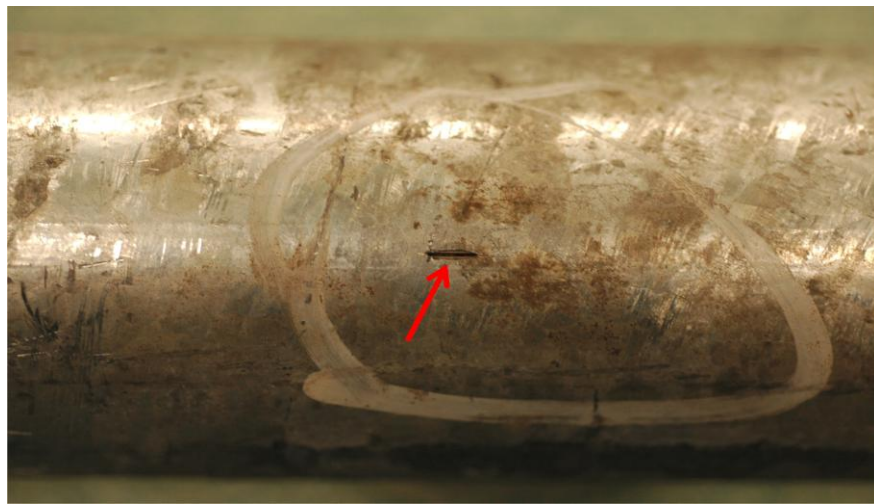
Figure 5.4 Photograph showing preferential grooving attack surrounding the weld seam area in a preaction system.

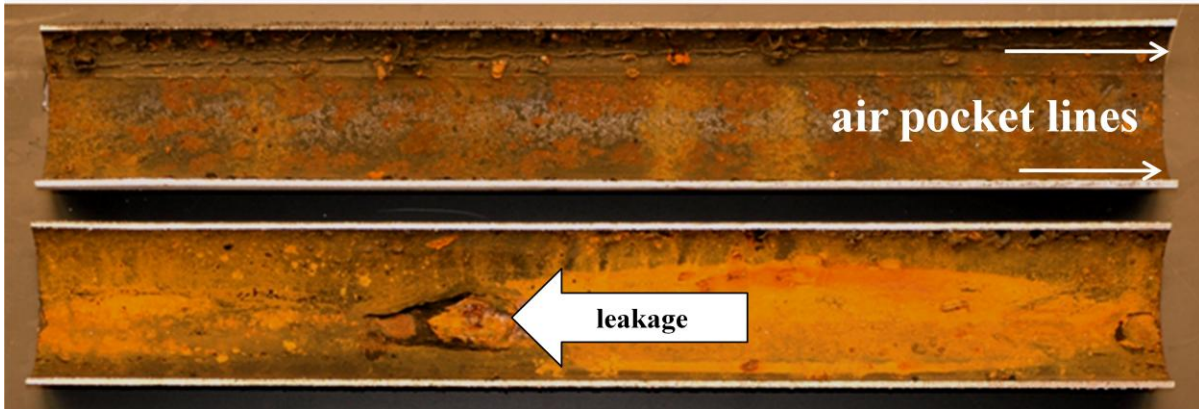
Figure 5.5 Photograph showing the leakage section of a pipe where the air gap filled approximately 40% of the volume in a wet pipe system.

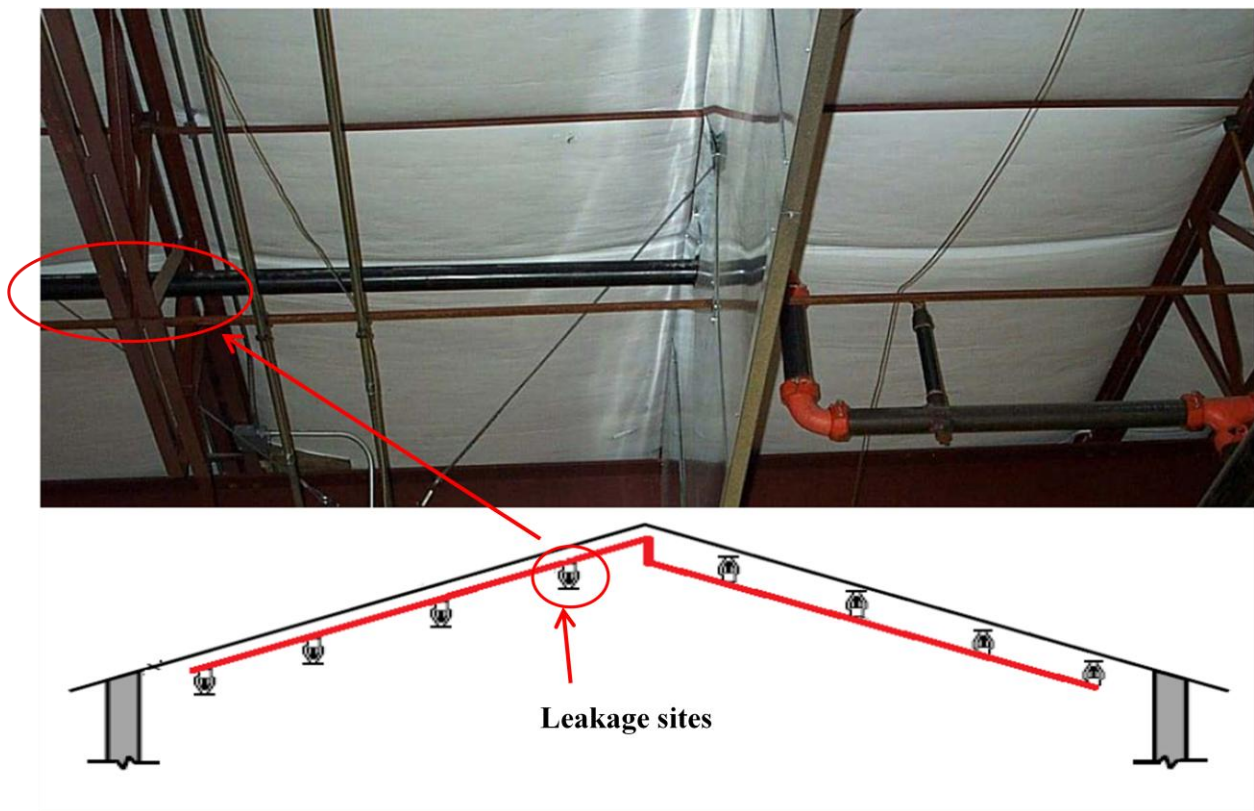
Figure 5.6 Photograph showing leakage sites in a wet pipe system due to trapped air.

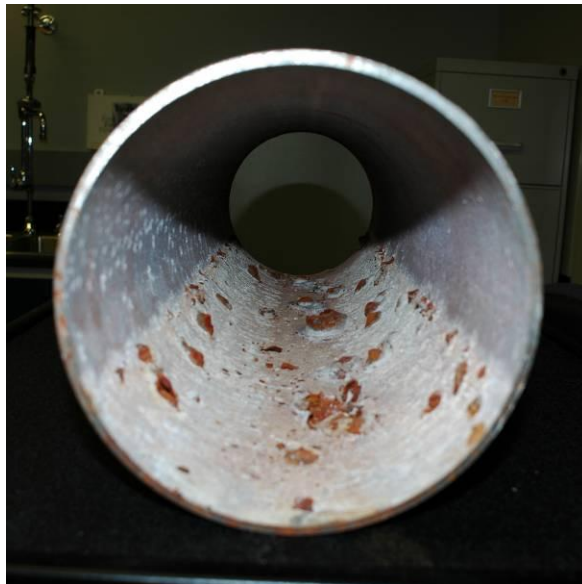
Figure 5.7 Photograph showing corrosion of galvanized steel pipe (NPS 6, Schedule 10) where residual water filled about 40% of the pipe's volume in a dry pipe system.

2. Fill dry pipe or preaction systems with nitrogen as supervisory gas (e.g., use on-site nitrogen generator) to mitigate galvanized steel pipe corrosion in the dry type FPS.
3. Install an FM Approved air-venting device to remove trapped air in wet pipe systems to mitigate pipe corrosion near air pockets.
4. Use treated water such as municipal water (i.e., avoid untreated raw water) as the source of sprinkler water for better water quality and less corrosion of FPS.
5. Apply only those chemicals (e.g., pipe cutting oil, adhesives, paints, antifreeze, etc.) approved by Lubrizol, FM Global, and UL for hybrid CPVC fire protection systems to avoid potential environmental stress cracking (ESC) failure of CPVC piping material.

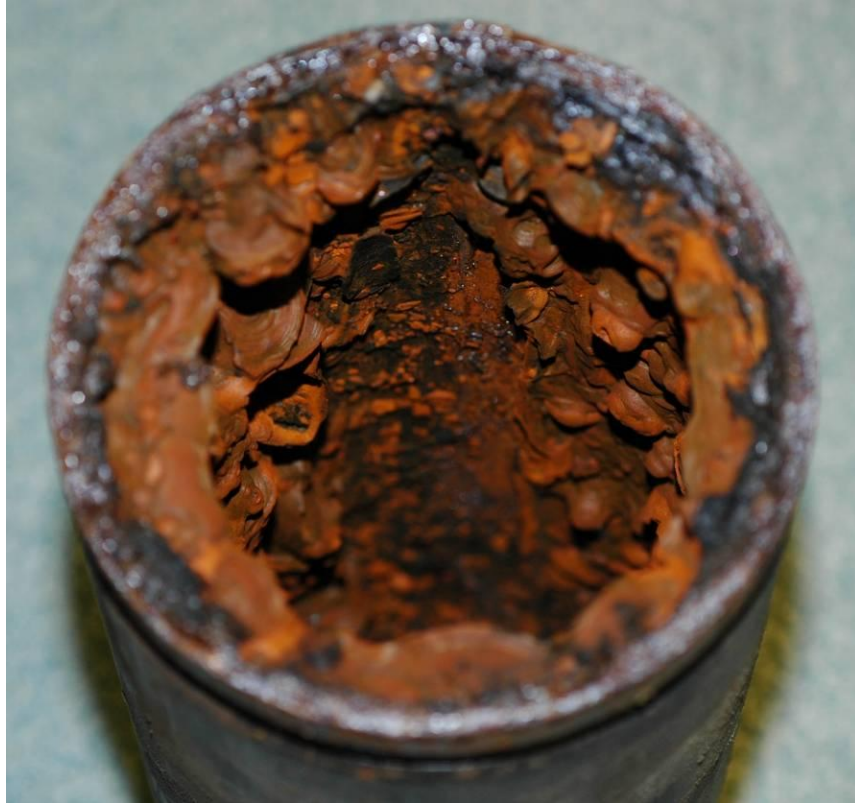
Figure 5.10 Photograph showing extensive tuberculation and deposit buildup for a portion of the Pipe Sample #1 in Table 5.2.

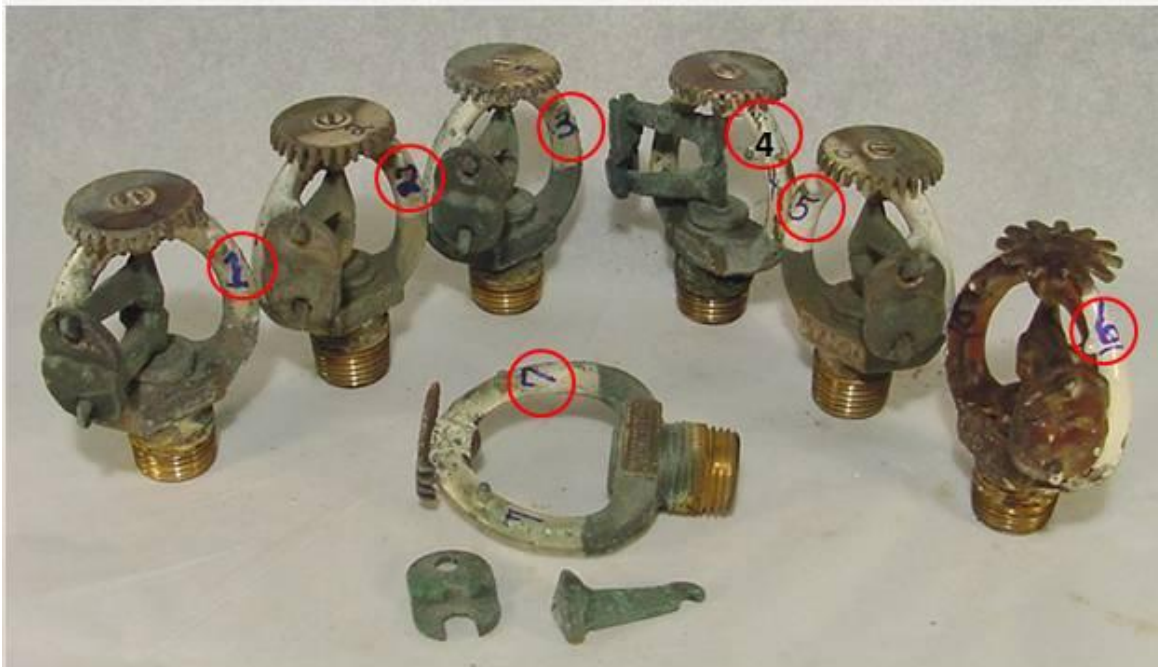
Figure 5.13 Photograph showing six intact (top, #1-6) and one prematurely operated (bottom, #7) sprinkler heads. The #7 sprinkler's fusible link halves had separated during the premature operation incident.

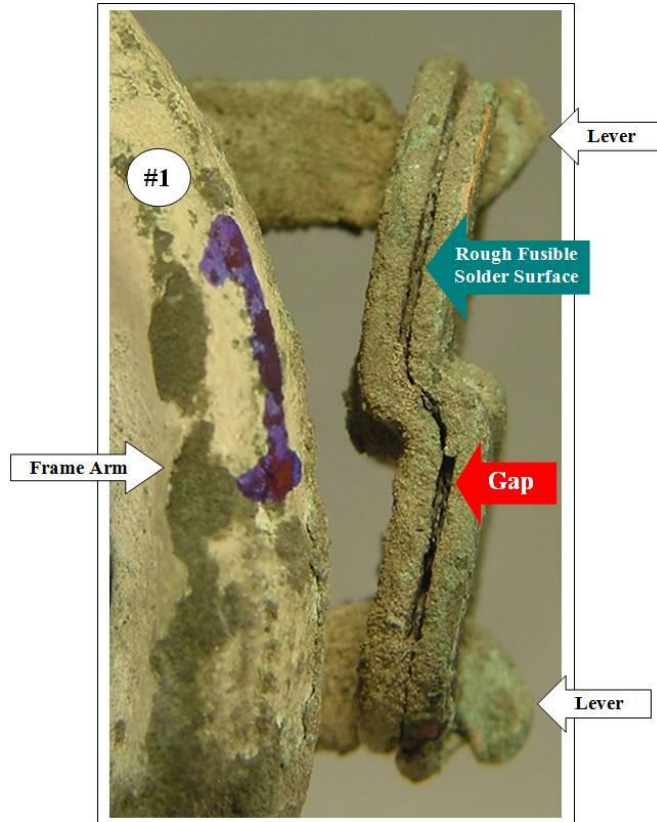
Figure 5.14 Photograph showing a side view of the fusible link halves from Sprinkler #1. A significant gap is present between the two link halves. The exposed surface of the fusible solder visible between the link halves has a rough surface, consistent with corrosion attack.

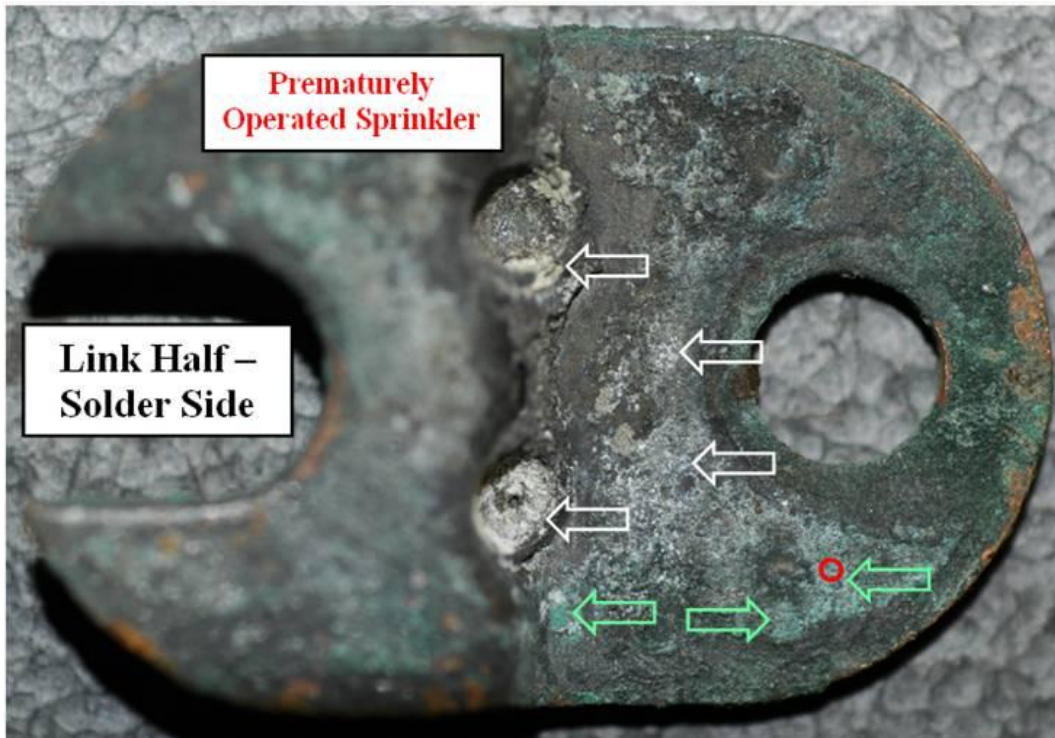
Figure 5.15 Close-up photograph of the fracture surface (solder side) of the link half from the prematurely operated sprinkler.
