CORROSION IN AUTOMATIC SPRINKLER SYSTEMS

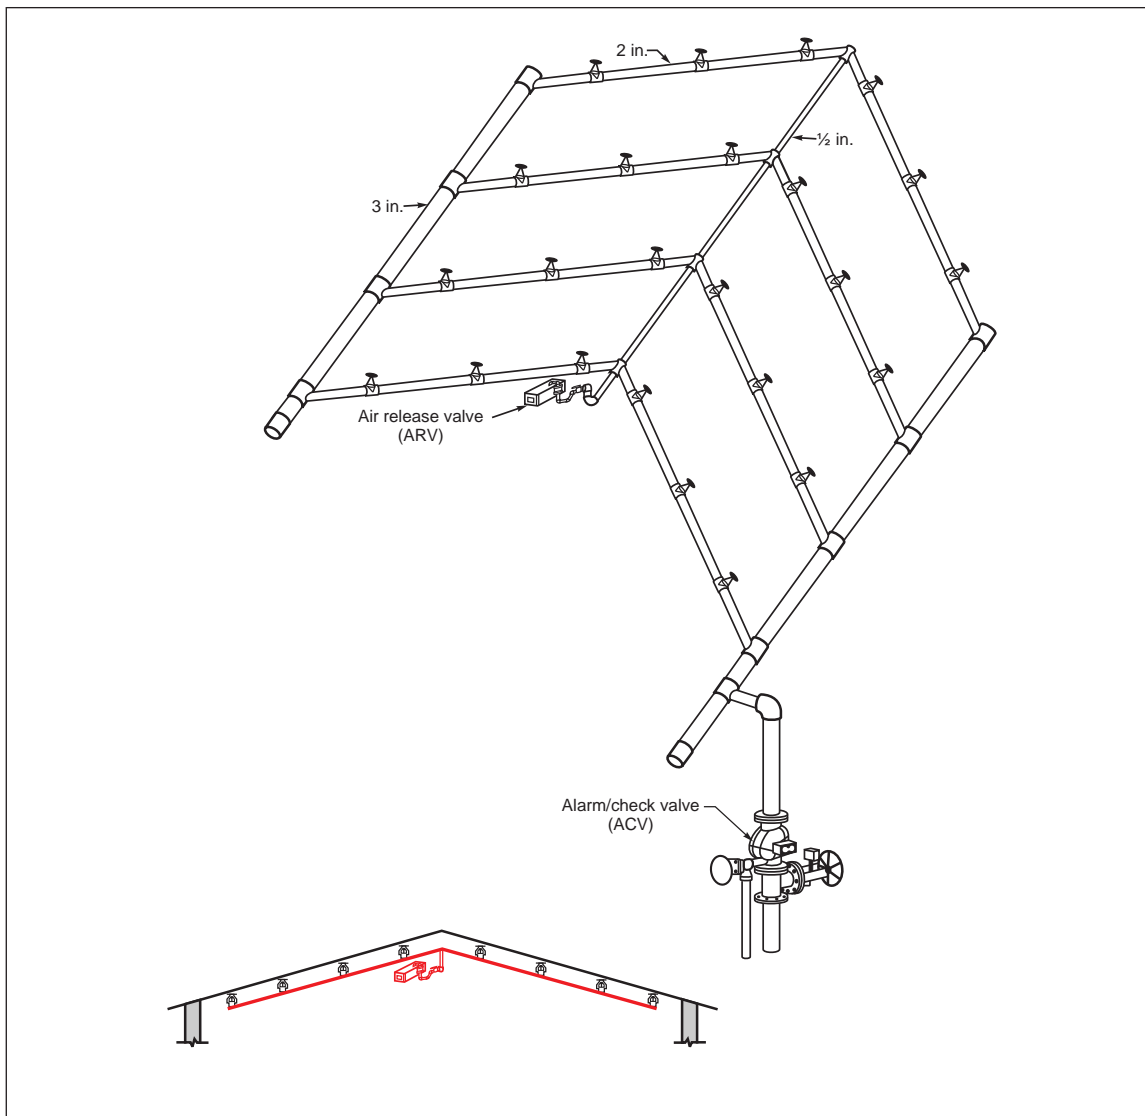
Fig. 1. Example of wet sprinkler piping arranged with an automatic air-release valve

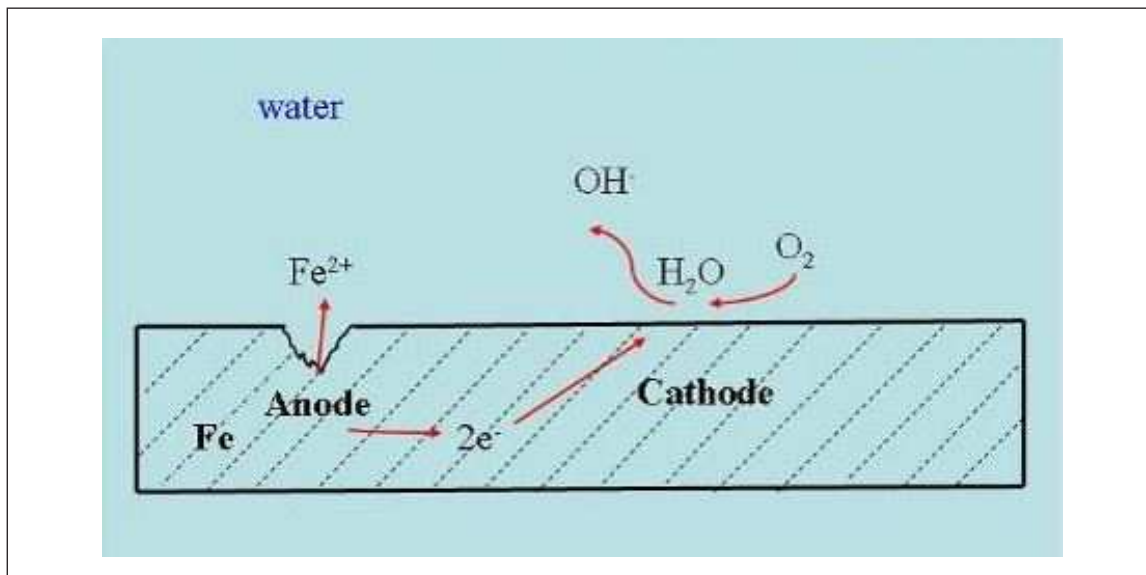
Figure 2 shows a schematic illustration of iron (Fe) corrosion in water. The Fe dissolves into Fe^{2+} at the anode and liberates electrons (e^-) reacting with O_2 and water to form hydroxide ions (OH^-) at the cathode (oxygen reduction reaction). In general, when a fire protection system (FPS) is supplied with sprinkler water containing oxygen, corrosion of steel or galvanized steel pipe (anodic reaction) in the FPS will occur and continue until oxygen in the water (cathodic reaction) is depleted by the corrosion reactions.

Fig. 2. Schematic illustration of iron (Fe) corrosion in water

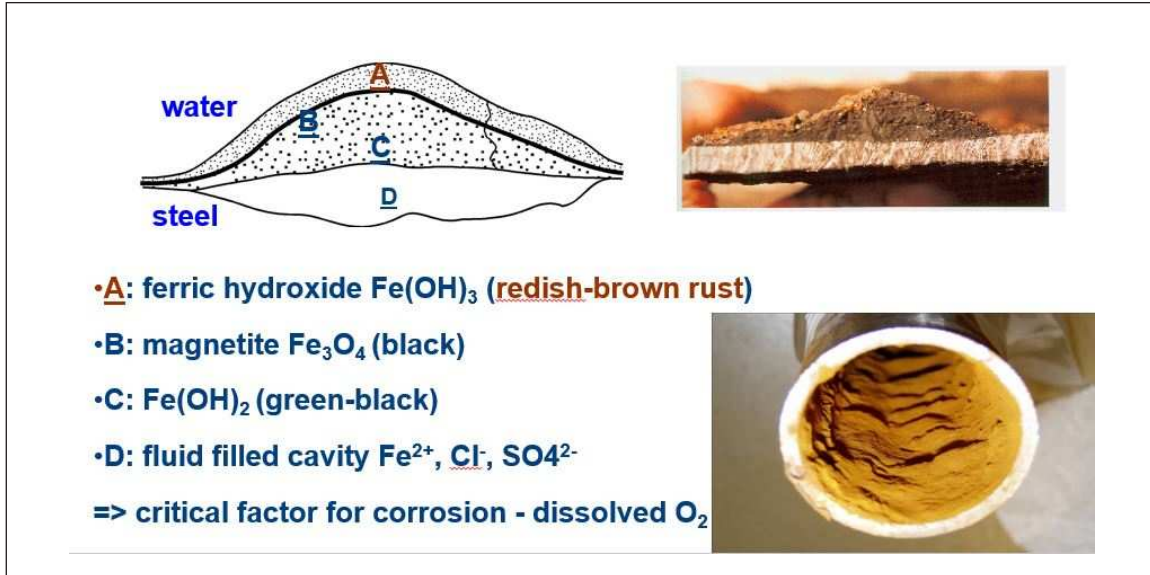
Many structural alloys corrode merely from exposure to moisture in air, but the process can be strongly affected by exposure to certain substances. Corrosion can be concentrated locally to form a pit or it can extend across a wide area, more or less uniformly corroding the surface (Figure 3).

Fig. 3. Development of corrosion

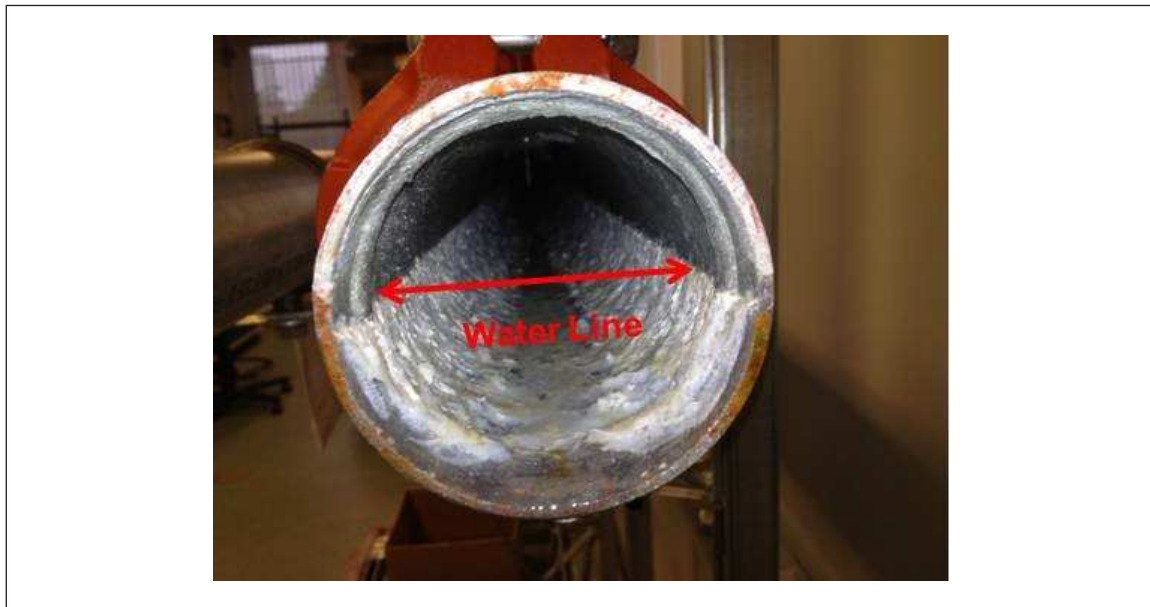
Figures 4a and 4b are photographs of galvanized steel pipe half-filled with tap water in house air (4a) and in compressed nitrogen (4b) after nearly six weeks' exposure. Whitish zinc corrosion products covered the bottom half of the house air-filled pipe in Figure 4a, but only limited zinc corrosion products covered the bottom half of the compressed nitrogen-filled pipe (Figure 4b). This result indicates that compressed nitrogen can reduce corrosion of galvanized steel pipe containing trapped water.

Fig. 4a. Galvanized steel pipe half-filled with tap water in house air after nearly six weeks' exposure

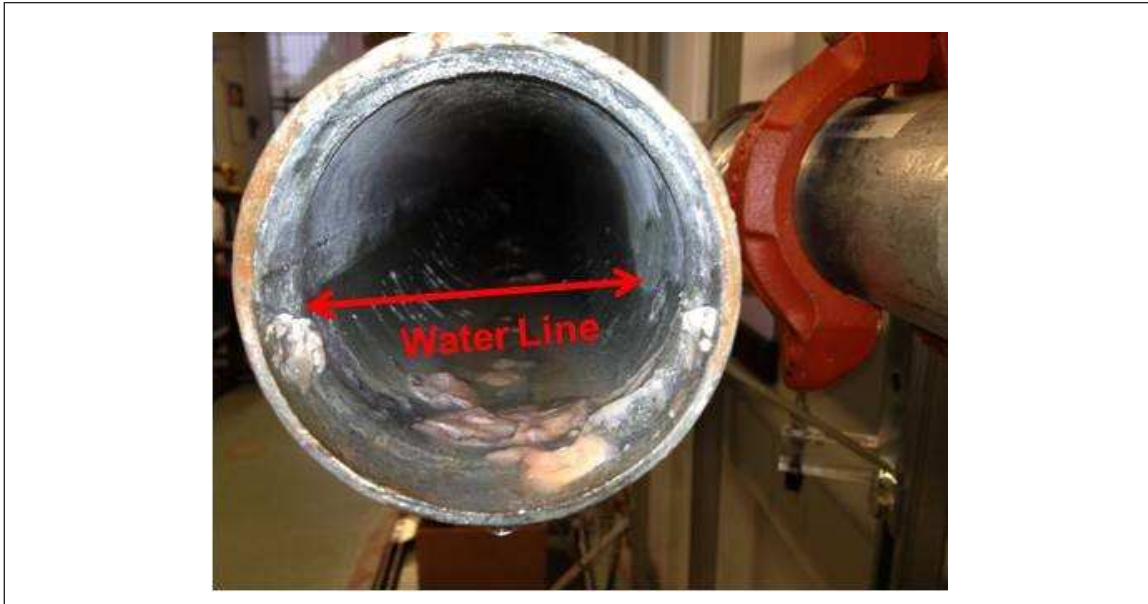
Fig. 4b. Galvanized steel pipe half-filled with compressed nitrogen after nearly six weeks' exposure

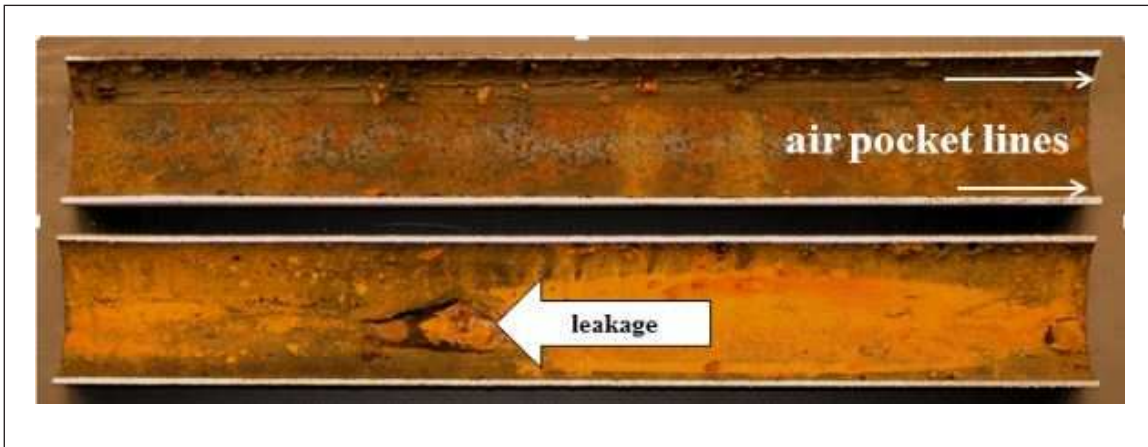
Figure 5 shows the section of a pipe in which the air gap filled approximately 40% of the volume in a wet pipe system, providing the oxygen source for steel pipe corrosion. The through-wall leakage site is indicated and the two parallel lines point to the air pocket boundary in the pipe. Note the significant tuberculation, corrosion, and deposit buildup in the bottom half of the pipe. The arrow points to a large tubercle, beneath which was the site of the leakage.

Fig. 5. Leakage section of a pipe where the air gap filled approximately 40% of the volume in a wet-pipe system

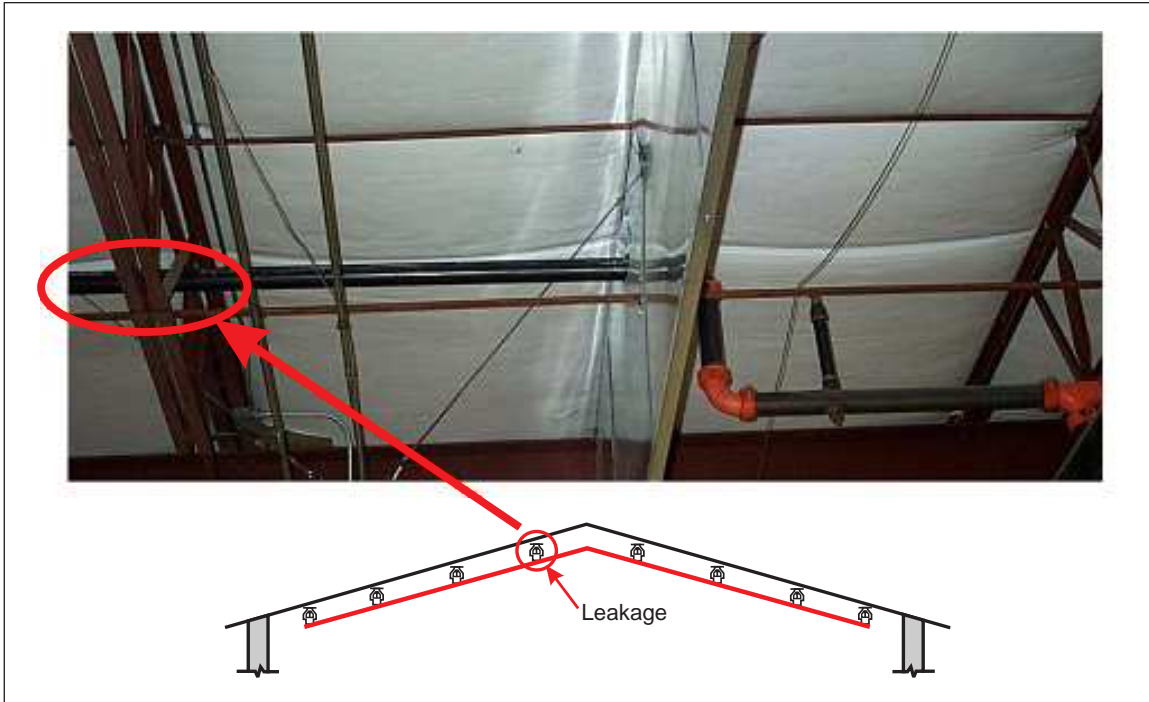
Figure 6 shows leakage sites of a wet pipe system due to trapped air. The leakage sites were at the left in the picture and near the roof bar joist as indicated. They were 10-15 ft to the left of the highest point in the system.

Fig. 6. Leakage sites of a wet pipe system due to trapped air

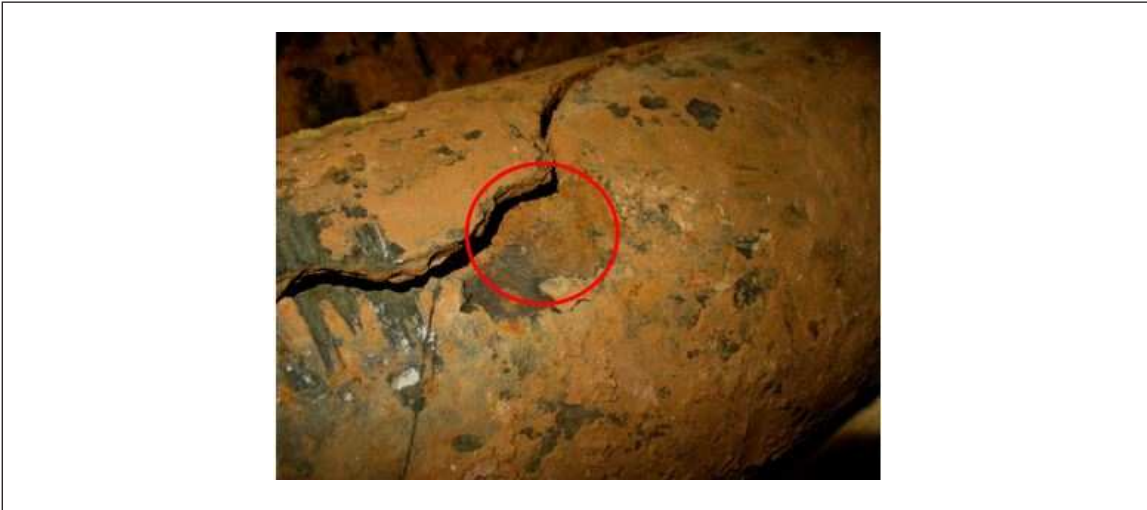
Figure 7 shows a ruptured underground water main (identified as gray cast iron, 8 in. [20.3 cm] diameter) with cement lining on its inside diameter. The circled area in Figure 7 shows graphitic corrosion on the outside surface of the main due to its exposure to mildly aggressive groundwater and soils. Generally, high moisture content in the surrounding soil is required for graphitic corrosion to occur.

Fig. 7. Ruptured underground water main (identified as gray cast iron, 8 in. [20.3 cm] diameter) with cement lining on its inside diameter

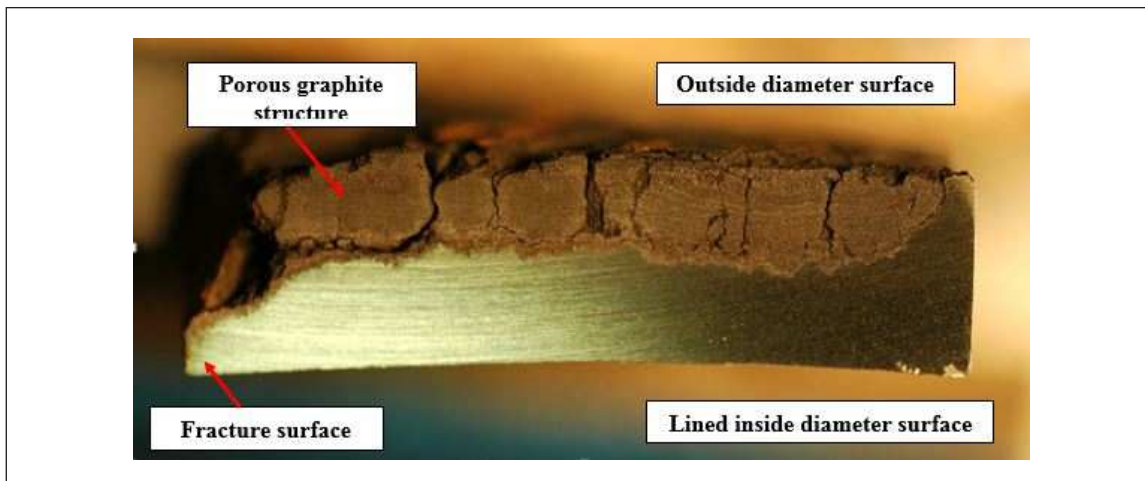
Figure 8 shows a cross section for part of the water main in Figure 7. It is noted that almost the entire wall thickness of the pipe has been penetrated by graphitic corrosion attack at the far left fracture surface, while the pipe's inside diameter surface with cement lining is in good condition.

Fig. 8. Cross section for part of the water main in Figure 7

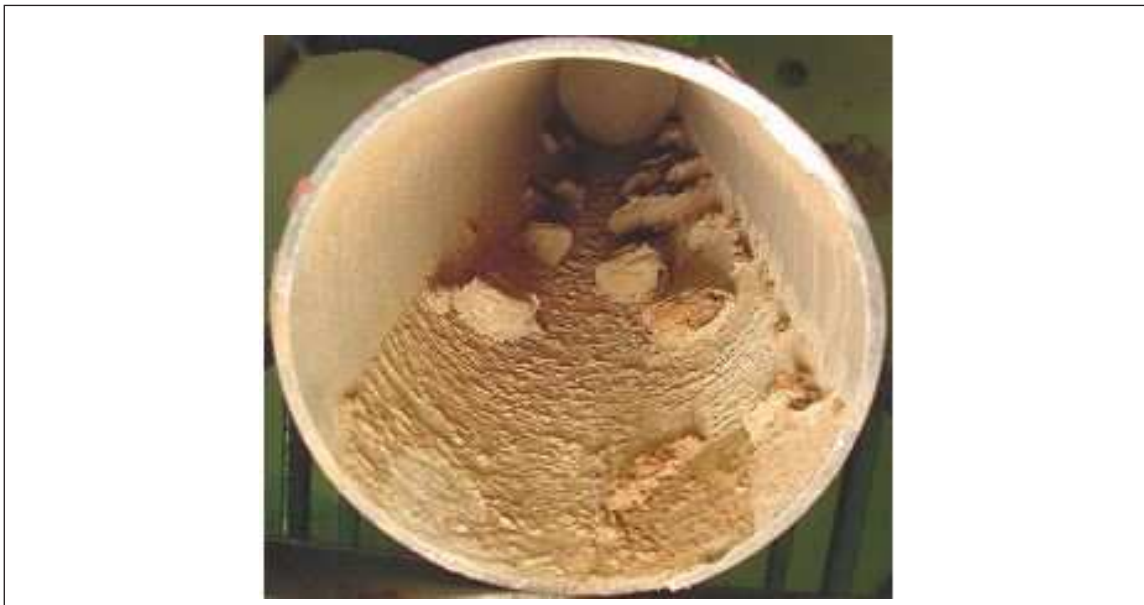
Figure 9a shows tubercles and and Figure 9b shows pinhole leakage (circled) in galvanized steel sprinkler pipe from dry-pipe systems.

Fig. 9a. Tubercles that formed inside a galvanized steel sprinkler pipe (4 in. [10 cm] diameter)

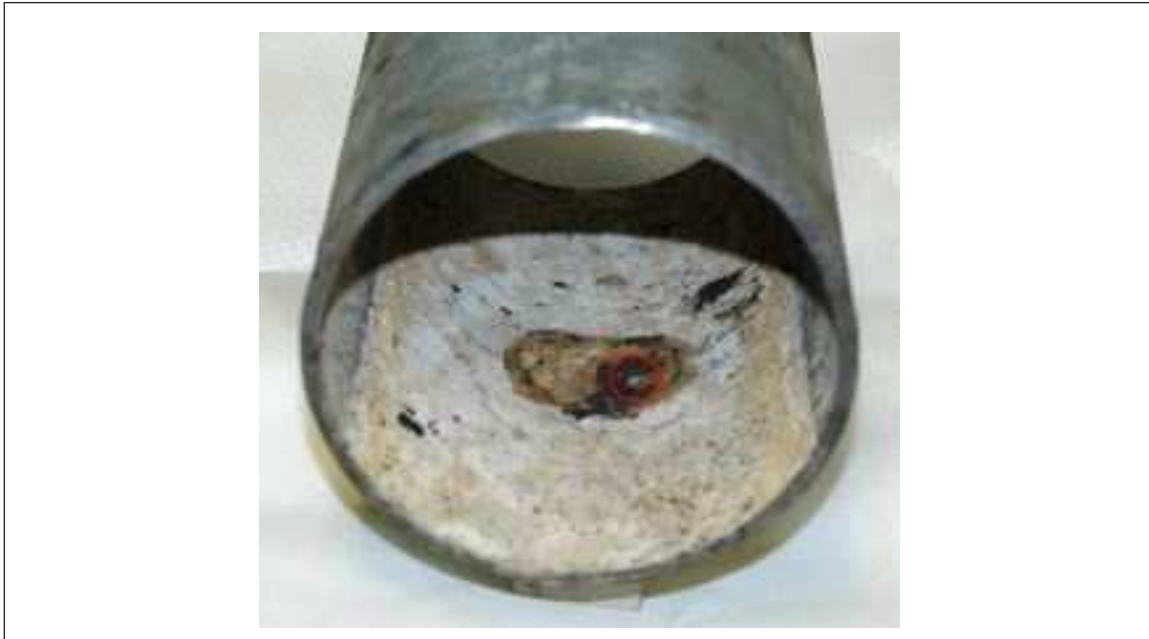
Fig. 9b. Corrosion at the base of a tubercle, which ultimately led to through-wall leakage

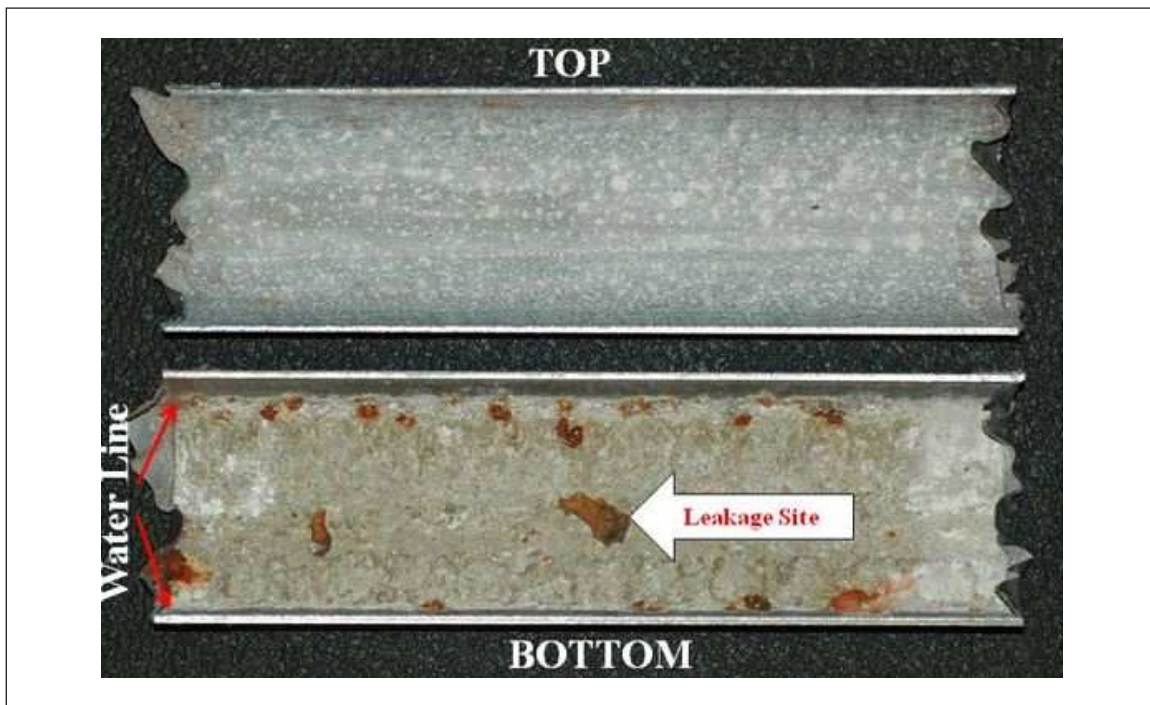
Figure 10 shows NPS 4 galvanized steel pipe (4.5 in. [11.4 cm] OD) with through-wall leakage. Residual water filled about 40% of the pipe's volume in service. Under the waterline, white rust (zinc corrosion) and well over a dozen reddish-brown tubercles of various sizes are evident on the bottom half of the pipe. The corrosion remains localized. The top half of the pipe is free of corrosion while the bottom half has significant corrosion.

Fig. 10. NPS 4 galvanized steel pipe (4.5 in. [11.4 cm] OD) with through-wall leakage

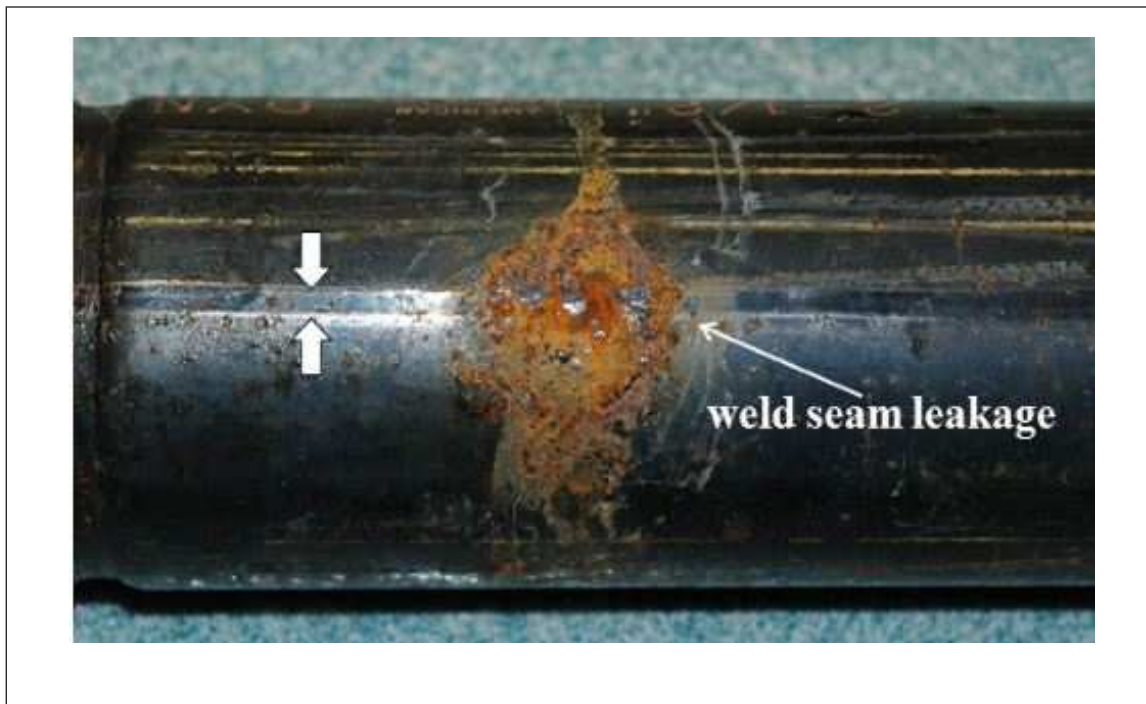
Figures 11a and 11b show leakage on an NPS 2½ steel sprinkler pipe in a wet pipe system. The weld seam leakage site and the location of the weld seam are indicated by arrows in Fig. 11b. Leakage on an NPS 2½ steel sprinkler pipe in a wet pipe system after removal of corrosion products; preferential attack surrounding the weld seam is severe

Fig. 11a. Leakage on an NPS 2½ steel sprinkler pipe in a wet pipe system; arrows indicate the weld seam leakage site and the location of the weld seam

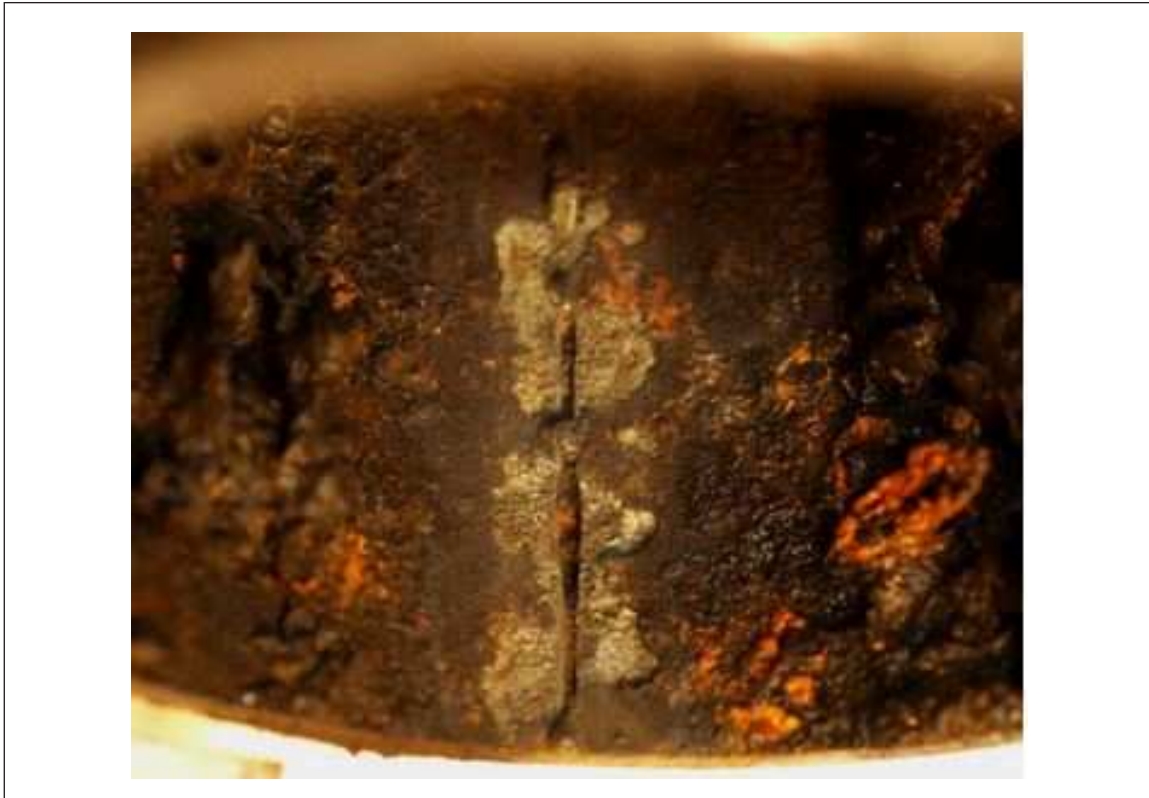
Figure 11b shows the waterside of the pipe in the region corresponding to the leakage site, after removal of corrosion products. Preferential attack surrounding the weld seam is severe.

Fig. 11b. Leakage on an NPS 2½ steel sprinkler pipe in a wet pipe system after removal of corrosion products; preferential attack surrounding the weld seam is severe

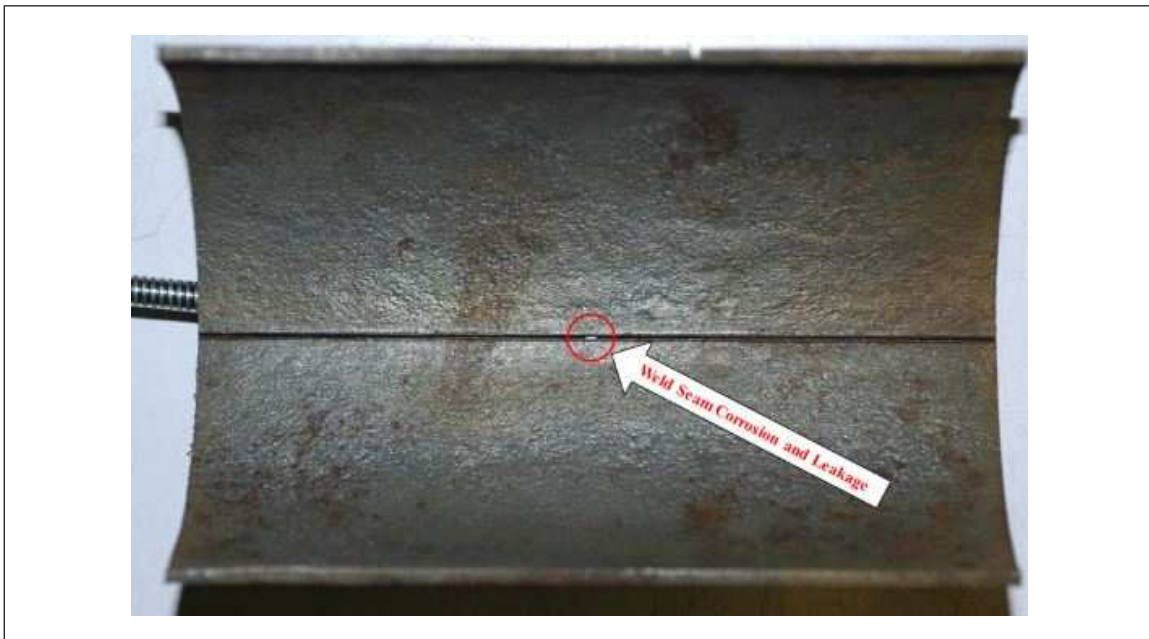
Figure 12 shows an example of preferential grooving corrosion on a pipe weld seam with a .04 in. (1 mm) pinhole leak in a wet-pipe system, after removing corrosion products inside an NPS 3 pipe.

Fig. 12. Preferential grooving corrosion on a pipe weld seam with a .04 in. (1 mm) pinhole leak in a wet pipe system, after removing corrosion products inside an NPS 3 pipe

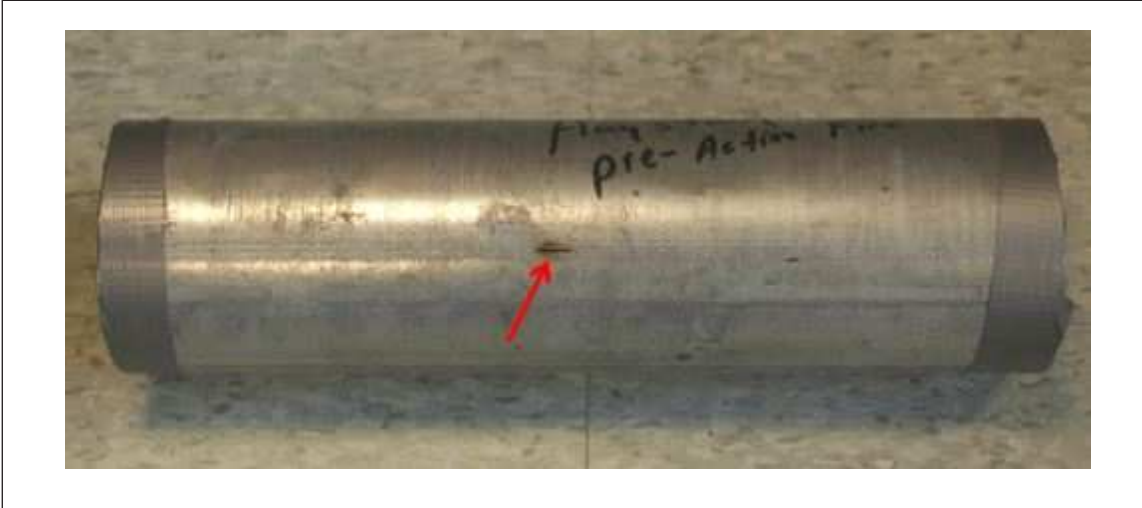
Figure 13 shows grooving corrosion of a longitudinal through-wall leakage in a galvanized steel pipe along its weld seam in a preaction system. The leak occurred beneath a large tubercle along the pipe's approximate 6 o'clock installed position. The arrow points a longitudinal through-wall leakage site on the pipe.

Fig. 13. Grooving corrosion of a longitudinal through-wall leakage in a galvanized steel pipe along its weld seam in a preaction

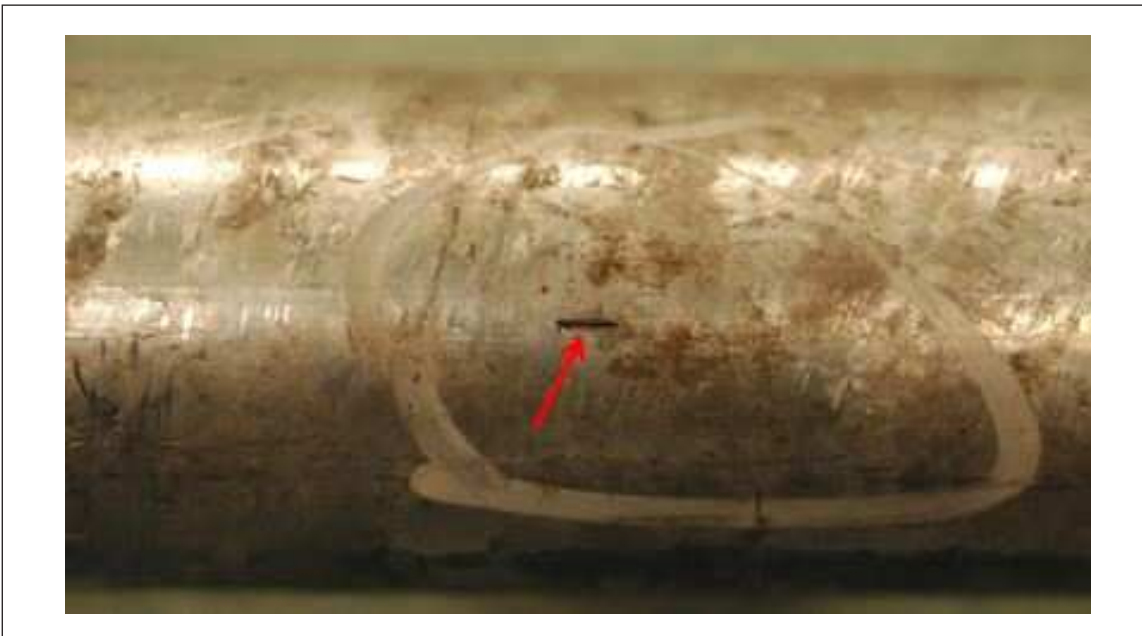
Figure 14 shows another preferential grooving corrosion attack surrounding the weld seam area for a preaction system, near the pipe's 6 o'clock (bottom) installed position.

Fig. 14. Preferential grooving corrosion attack surrounding the weld seam area for a preaction system, near the pipe's 6 o'clock (bottom) installed position

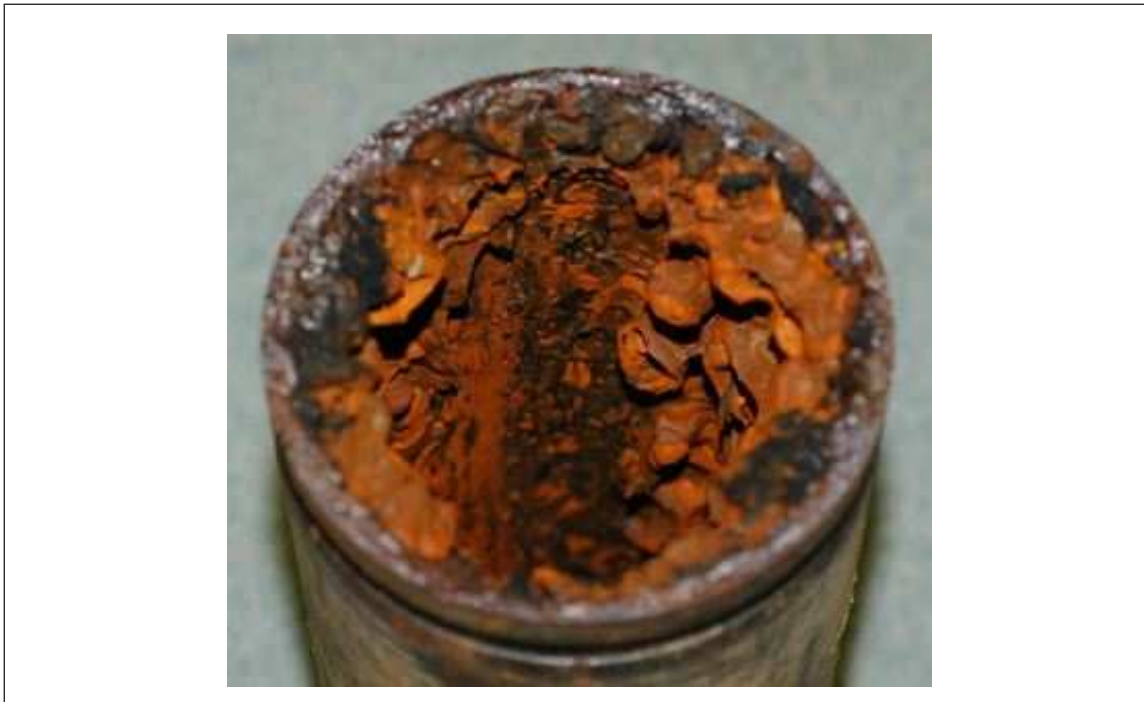
Figure 15 is an example of a 4 in. (10 cm) diameter corroded/leaking steel pipe with many tubercles formed inside the pipe. MIC caused by SRB was identified to be a likely contributing factor to the corrosion based on testing results of SRB immunoassay, lead acetate sulfide tests, water chemistry analyses, and corrosion/metallurgical evidence.

Fig. 15. Corroded steel pipe with many tubercles inside
