Corrosion of Piping in Dry and Preaction Fire Sprinkler Systems:

**Interim Results of Long Term Corrosion Testing Under Compressed
Air and Nitrogen Supervision**

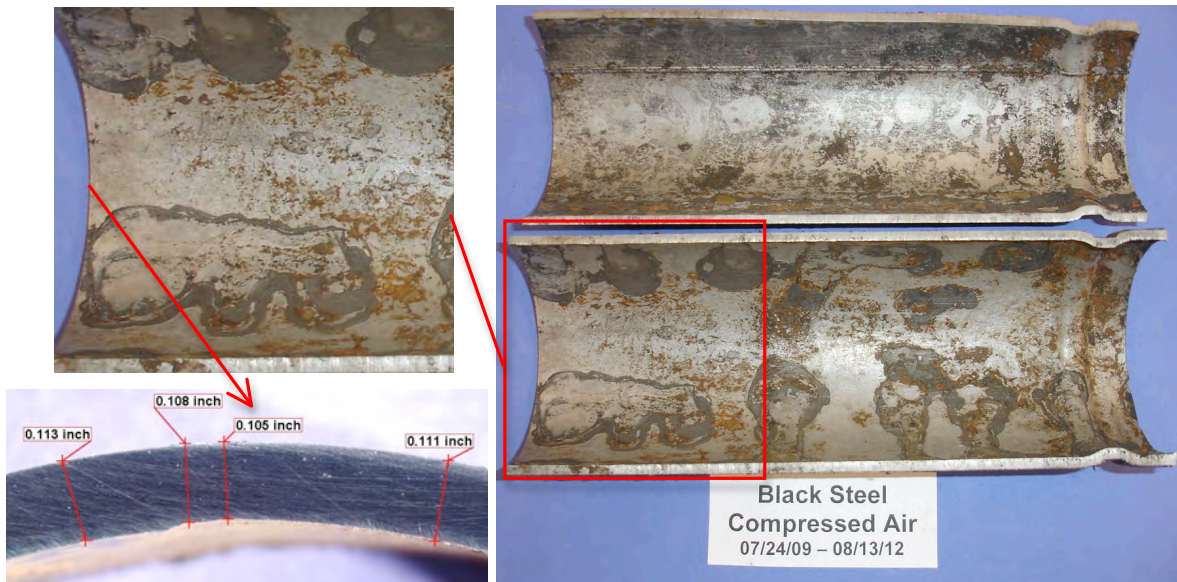
Figure 2. Composite image of black steel piping after 1116 days exposure while approximately half-filled with water and under compressed air supervision. Note uniform thinning of pipe wall and absence of any localized pits.

Examination of the tested black steel pipe sections under both compressed air and nitrogen supervision exhibited uniform loss in thickness of the pipe wall in the portion of the pipe that was submerged in water (Figure 2, Figure 3, and Figure 4). No localized pits were noted in any of the pipe sections. Calculated corrosion penetration rates show a progressive decrease from an average rate of 7.3 mils per year (mpy) under compressed air to 5.9 mpy under 95% nitrogen supervision to 2.5 mpy under 98% nitrogen supervision. Based on the nominal wall thickness of 0.120" for this schedule and diameter of pipe, this translates to respective time-to-penetration periods of 16.4 years under compressed air supervision, 20.3 years under 95% nitrogen supervision and 48 years under 98% nitrogen supervision.

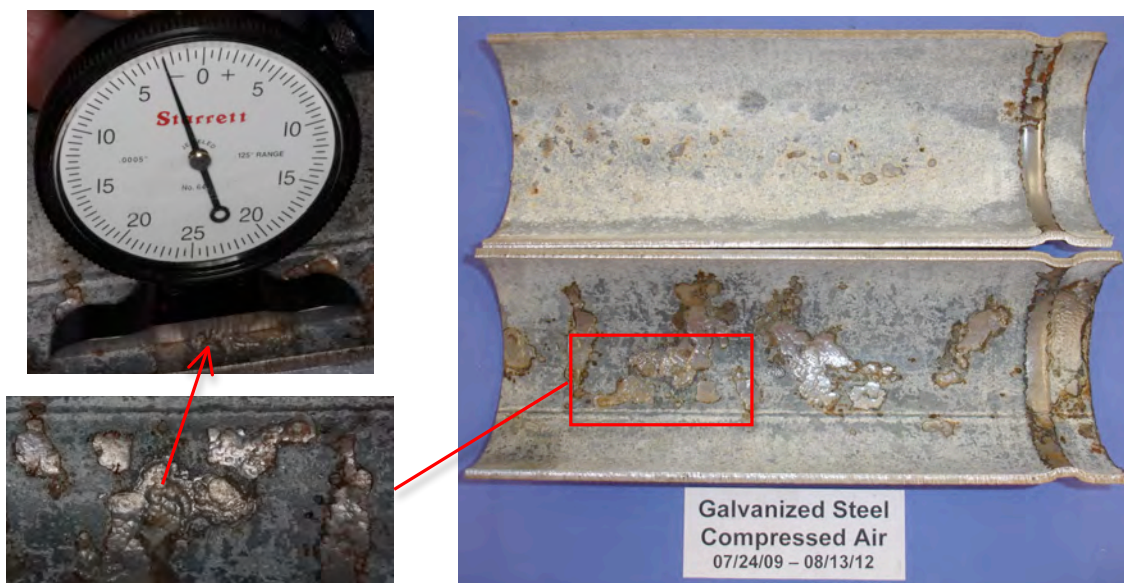
Figure 5. Galvanized piping after 1116 days exposure while approximately half-filled with water and under compressed air supervision. Note localized pitting at locations where zinc coating has been breached.

The galvanized steel pipe sections under both compressed air and 95% nitrogen supervision showed localized pits underlying locations where brown to black nodules or tubercles had formed (Figure 5 and Figure 6). No localized penetration of the zinc layer and subsequent formation of localized pits were noted on the galvanized steel under 98% nitrogen supervision (Figure 7). Calculated corrosion penetration rates (based on pit depth measurements for the air and 95% nitrogen supervised pipe sections and cross-sectional remaining wall thickness measurement for the 98% nitrogen supervised pipe section), show a progressive decrease from an average rate of 17.5 mpy under compressed air to 11.5 mpy under 95% nitrogen supervision to 1.3 mpy under 98% nitrogen supervision. Based on the nominal wall thickness of 0.125" for this schedule and diameter of pipe, this translates to respective time-to-penetration periods of 7.1 years

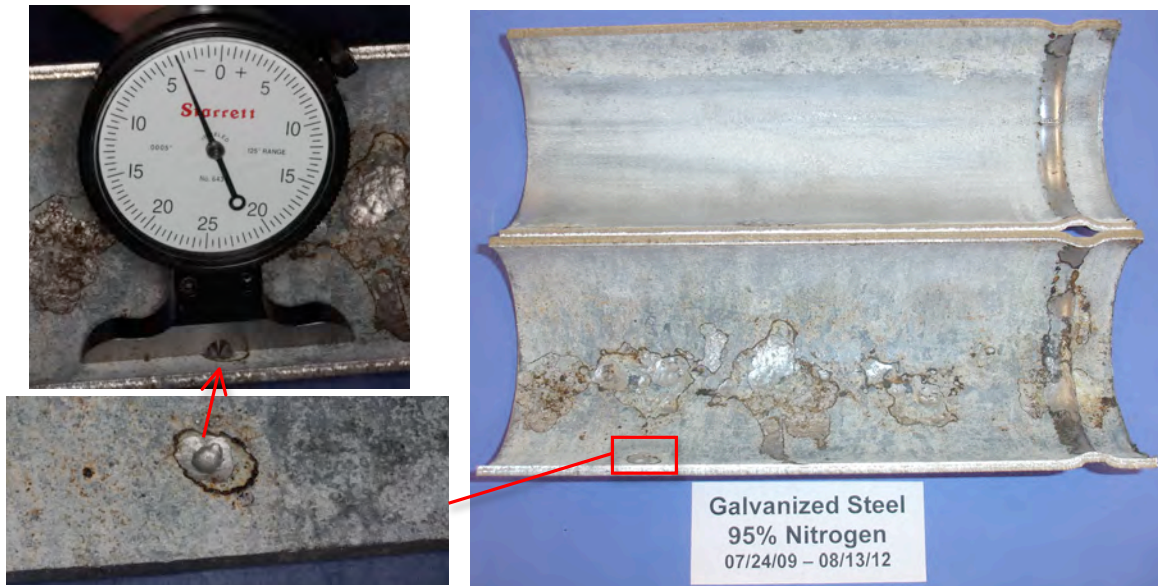
Figure 6. Galvanized piping after 1116 days exposure while approximately half-filled with water and under 95% nitrogen supervision. Note localized pitting at locations where zinc coating has been breached.
