TECHNICAL NOTE

NITROGEN-PAC™ M SERIES OIL-FILLED COMPRESSORS AND OIL “LEAKAGE”

This Technical Note clarifies what is normal and what may be abnormal when lubricating oil is observed on the outside of NITROGEN-PAC™ M Series Compressor / Tank Assemblies (CTAs).

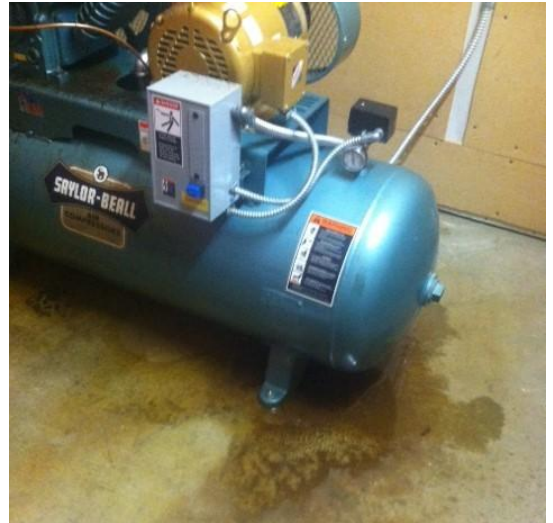
FIGURE 1 – NORMAL OIL DISCHARGE ON FLOOR

The pumps on CTAs do not, of course, burn the oil that travels past the rings. The oil discharges into the air storage tank, and collects with the water in the bottom of the tank. The oil and water are then discharged when the Auto-Drain on the bottom of the CTA tank operates. The manufacturer of our CTAs states that 5 parts per million of oil in the discharged water is normal, and will be visible (see **Figure 1**). If you see oil on the floor near the CTA, it is likely NOT a leak – it is simply the normal oil discharge. Simply wipe it up occasionally with a rag. If it is desired that no water or oil be present near the CTA, refer to manual P/N 30-NPMICM-000 and Technical Note UFS-16-02 for information about system drain connections.

If the amount of discharged oil appears much greater than normal, or the oil sight glass indicates the oil level is low (see **Figure 4**), the pump may require maintenance. Otherwise, consider the small amount of oil on the floor as normal, and not a leak.

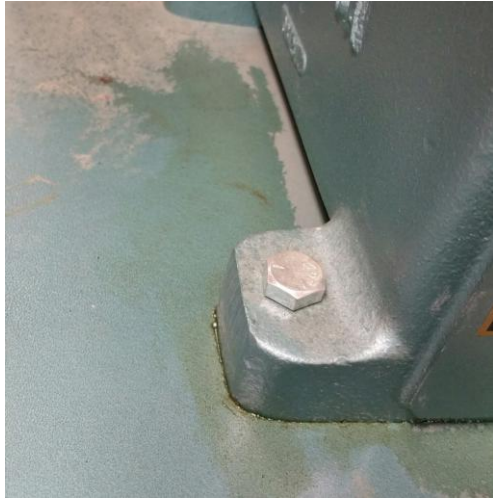
FIGURE 3 – NORMAL OIL ON BRACKET

If the amount of visible oil appears much greater than normal, or the oil sight glass indicates the oil level is low, the pump may require maintenance. Otherwise, consider the small amount of oil on the compressor bracket as normal, and not a leak.

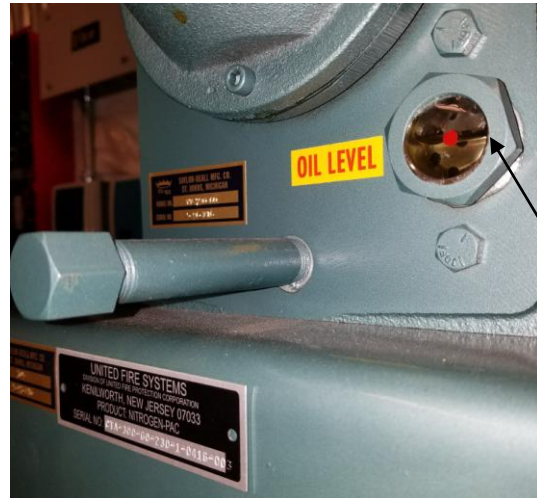
NORMAL OIL LEVEL

FIGURE 4 – OIL LEVEL SIGHT GLASS

- Check filter regulator pressure gage to make sure the reading is in the range of 145 ± 5 PSIG (100 ± 5 PSIG for Model CTA-150).
- Check level of compressor pump oil at sight glass (see **Figure 4**). Add oil if necessary. NEVER over-fill.
- Check ball valve #1 for NORMAL operating position – valve should be OPEN.
