Corrosion and Corrosion Mitigation in Fire Protection Systems

Paul Su and David B. Fuller

FM Global
1151 Boston-Providence Turnpike
Norwood, MA 02062

2nd Edition, July 2014

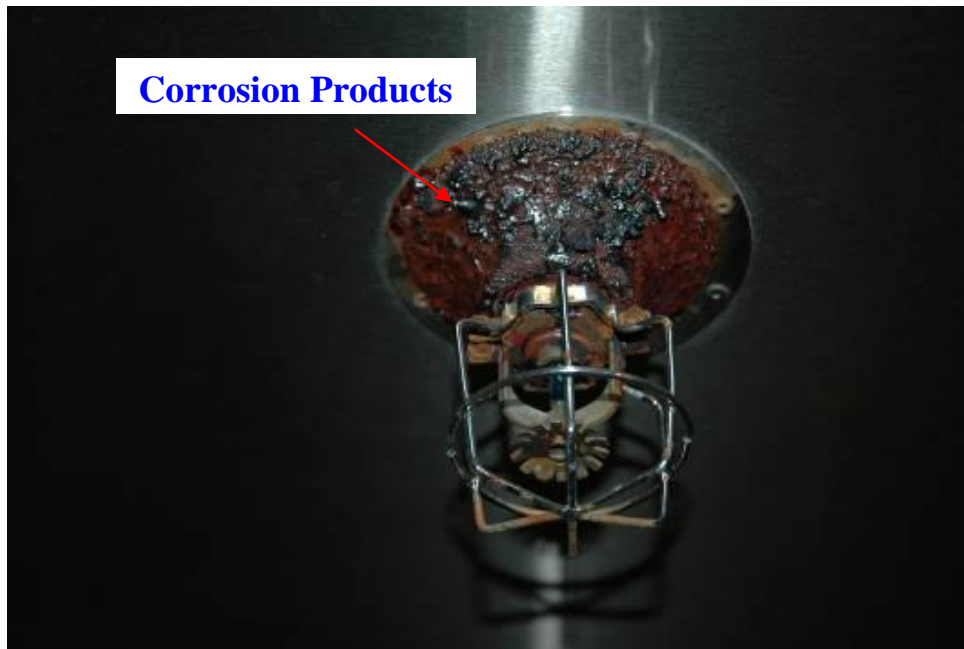
Figure 4.3 Photograph showing galvanic corrosion damage of a less noble steel connection (anode) contacting a large noble stainless steel plate (cathode) inside a high humidity environmental chamber.

Figure 4.3 shows galvanic corrosion damage of a less noble steel connection (anode) contacting a large noble stainless steel plate (cathode) inside a high humidity environmental chamber

without proper electrical insulation between these two metals. The deposits shown in Figure 4.3 are the corrosion products of the steel connection.

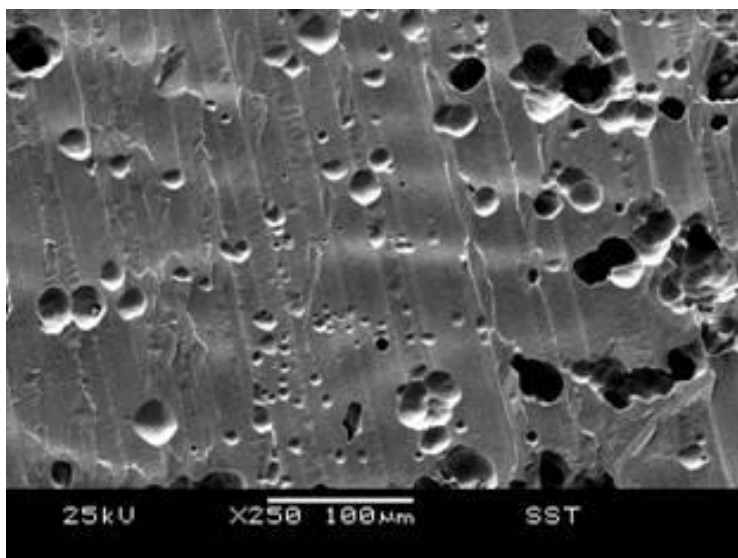
Figure 4.4 SEM photograph showing pits on a metal surface.

Figure 4.4 shows an scanning electron microscope (SEM) image of pits on a metal surface. It is noted that corrosion took place locally at many pits, while other areas on the metal surface are relatively intact.²⁰ The solution inside a pit can be very aggressive (e.g., acid with pH ~2 and Cl⁻), which increases the metal dissolution rate and is often called an autocatalytic process.

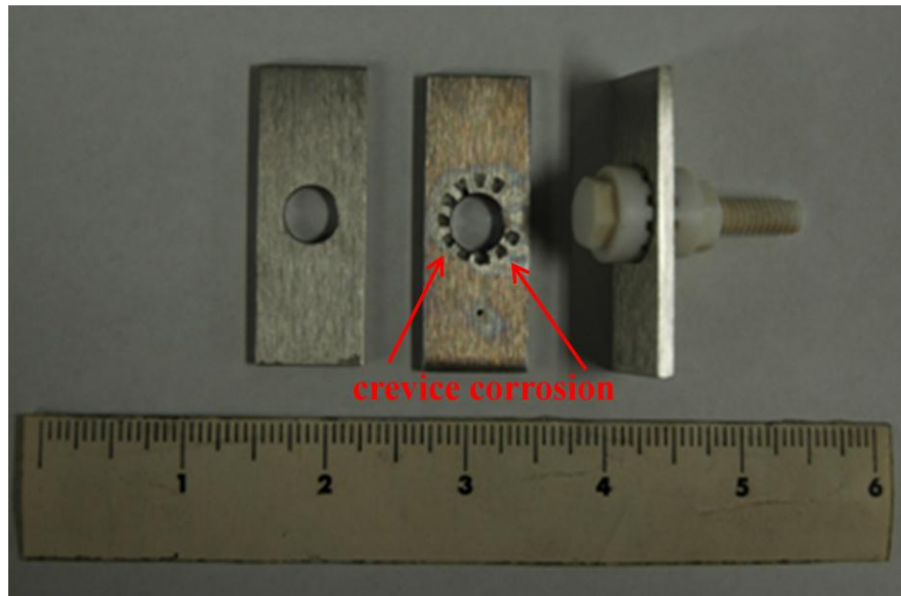
Figure 4.6 Photograph showing localized crevice corrosion attacks on a metal coupon (middle) underneath a PTFE artificial crevice washer at 75°C after 48 hours of exposure.

Figure 4.6 shows localized crevice corrosion attacks on a metal coupon (middle) underneath a polytetrafluoroethylene (PTFE) artificial crevice washer at 75°C after 48 hours of exposure.

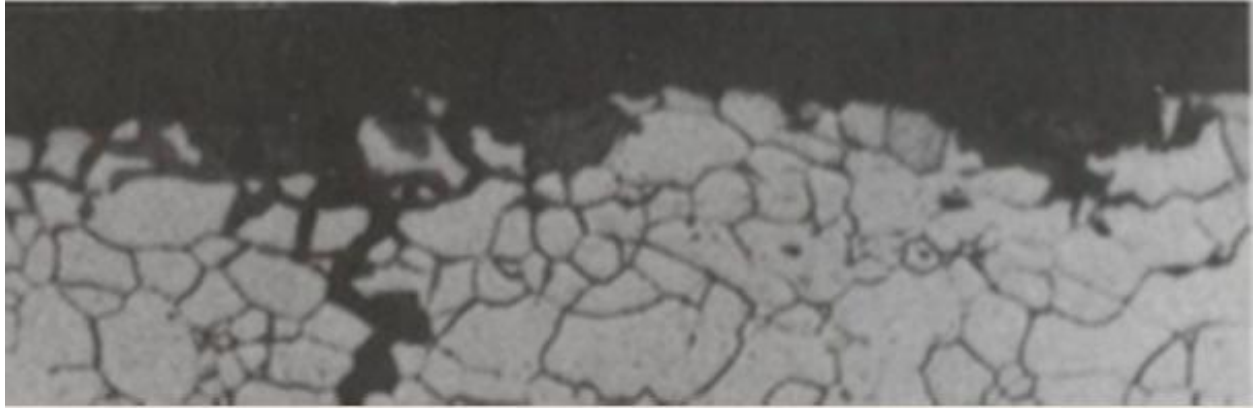
Figure 4.11 shows IGC and cracking of steel where the corrosion and cracking occurred along grain boundary areas without corroding the steel grain matrix.

Figure 4.11 Photomicrograph showing intergranular corrosion of steel surface where corrosion and cracking occurred along grain boundaries without corroding the steel grain matrix.

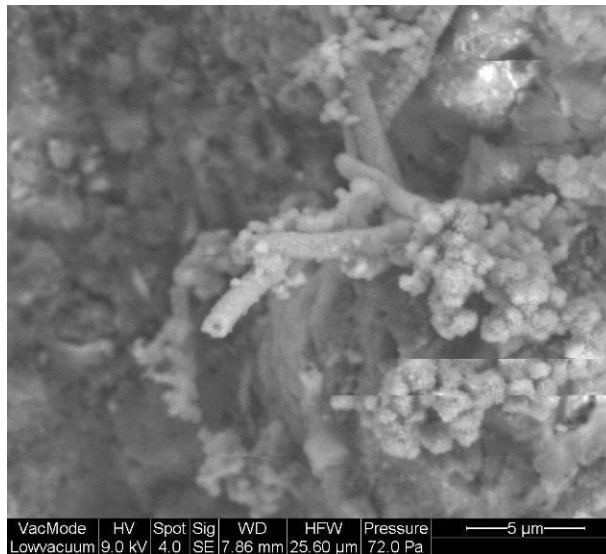
Figure 4.13 Representative SEM image of corroded steel with bacteria. The corrosion product, drinking straw-like structure, may be due to *Leptothrix ochracea*, iron-oxidizing bacteria on corroded steel pipe.

Figures 4.13 and 4.14 show representative SEM images of corroded steel with bacteria, indicating bacterial involvement in the corrosion process (i.e., MIC). Figure 4.13³⁴ displays an image of corroded steel pipe with corrosion product containing a drinking straw-like structure, which may be due to *Leptothrix ochracea* (iron-oxidizing bacteria). Figure 4.14⁴² displays rod-shaped *Desulfovibrio* sp. (SRB) on the galvanized steel surface after 8 hours of incubation. Figure 4.15 is an example of a 4 inch dia. corroded/leaked steel pipe with many tubercles formed inside the pipe. MIC caused by SRB was identified to be a likely contributing factor to pipe corrosion, based on testing results of SRB immunoassay, lead acetate sulfide tests, water chemistry analyses, and corrosion/metallurgical evidence (discussed in Section 5.5).

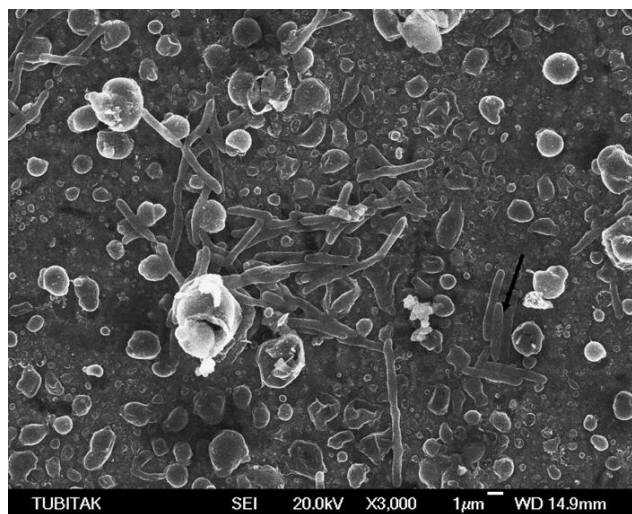
Figure 4.14 Representative SEM image of rod-shaped *Desulfovibrio* sp., sulfate-reducing bacteria on the galvanized steel surface after 8 hours of incubation.⁴² (Courtesy of Elsevier, August, 2011)

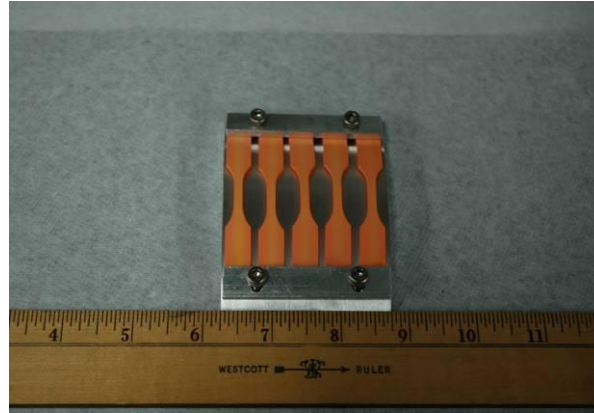
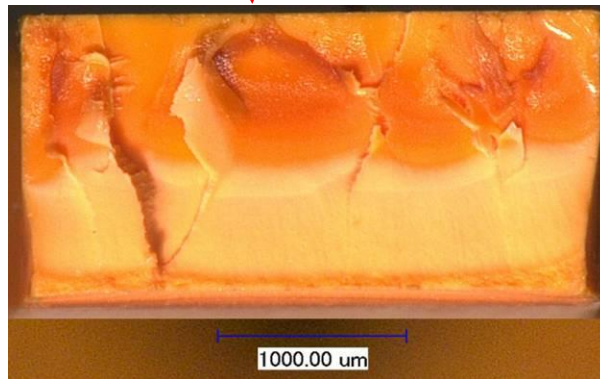
Figure 4.24 (A) shows five CPVC type V tensile specimens on a 1% strain jig for ESC testing of coating chemicals on black steel pipe.⁶⁰ Figure 4.24 (B) displays the fracture surface side view of a type V tensile specimen exposed to an ESC agent. The dark orange/glassy^{55,47} region indicates that the ESC agent has diffused into the specimen and the tensile stress has accelerated the diffusion process of this chemical; thus, eventually led to ESC fracture of the specimen.

Figure 4.24 Photographs showing (A) five CPVC type V tensile specimens on a 1% strain jig for ESC testing of coating chemicals on black steel pipe and (B) the fracture surface side view of a type V tensile specimen – ESC agent diffused into the specimen from exposed surface (top).

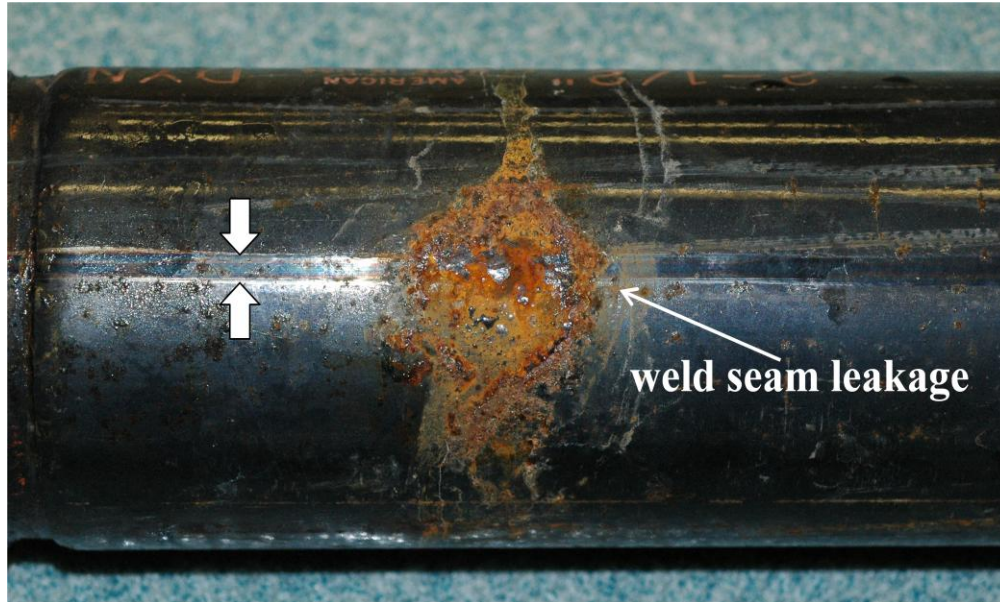
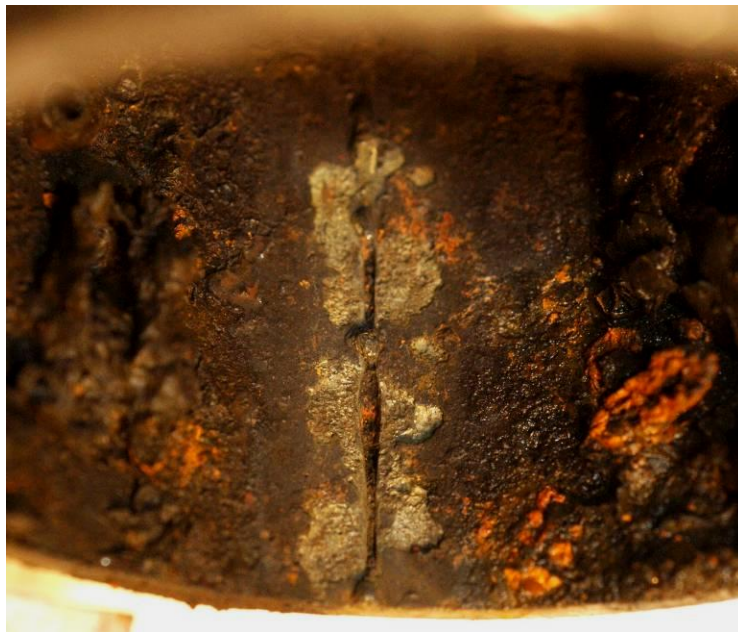
Figure 5.1 (A) and (B) shows leakage on an NPS 2½ steel sprinkler pipe in a wet pipe system. The weld seam leakage site and the location of the weld seam are indicated by arrows in Figure 5.1 (A). Figure 5.1 (B) shows the waterside of the pipe in the region corresponding to the leakage site, after removal of corrosion products. Preferential attack surrounding the weld seam is severe.

Figure 5.1 Photographs showing (A) Weld seam leakage site on a NPS 2½ sprinkler pipe with the location of the weld seam indicated by arrows. (B) The waterside of the pipe in the region corresponding to the leakage site, after removal of corrosion products. Preferential attack surrounding the weld seam is severe.

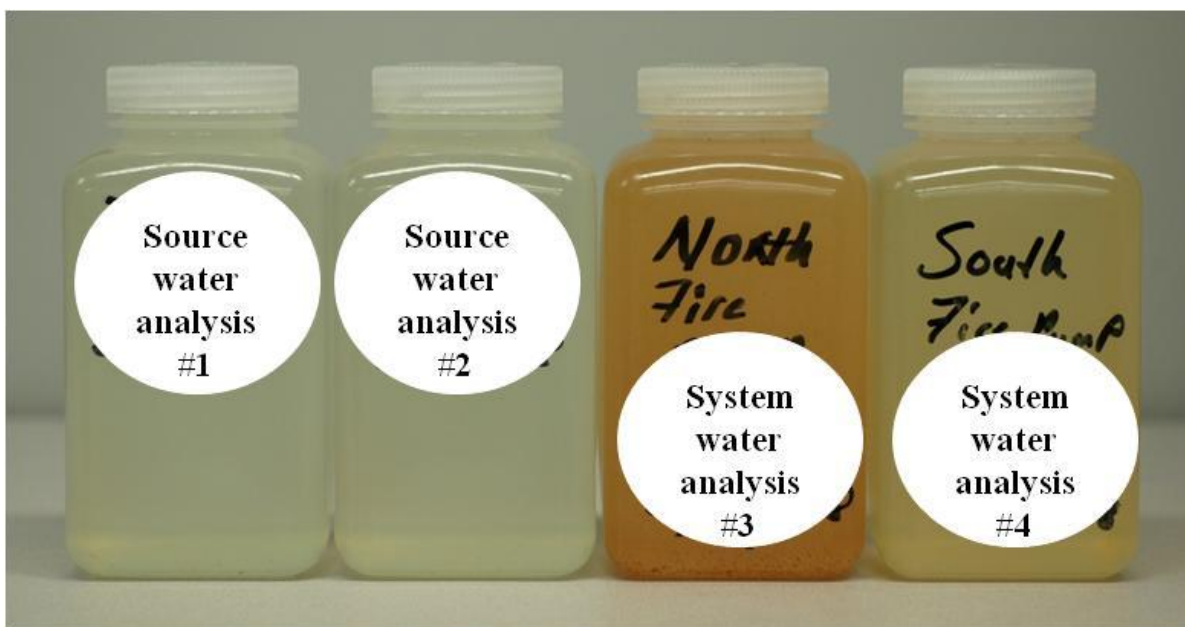
Figure 5.8 shows four water samples collected from a wet pipe system for water corrosivity analysis. Samples #1 and #2 were source water samples, while Samples #3 and #4 were fire pump line samples, respectively. The two source water samples were clear, while the fire pump water samples had a light brown and a light yellow color, respectively.

Figure 5.8 Photograph showing four water samples removed from a wet pipe system. Samples #1 and #2 were source water samples, while Samples #3 and #4 were fire pump line samples, respectively. The two source water samples were clear, while the fire pump water samples had a light brown and a light yellow color, respectively.

Chemical analyses were conducted on the four water samples in Figure 5.8; results are presented in Table 5.1. The findings were then evaluated to determine the corrosivity of the water samples to any carbon steel components with which they might come into contact. The Larson-Skold index of the water samples, calculated from their chloride, sulfate, and alkalinity values, were all determined to be over 4.77.

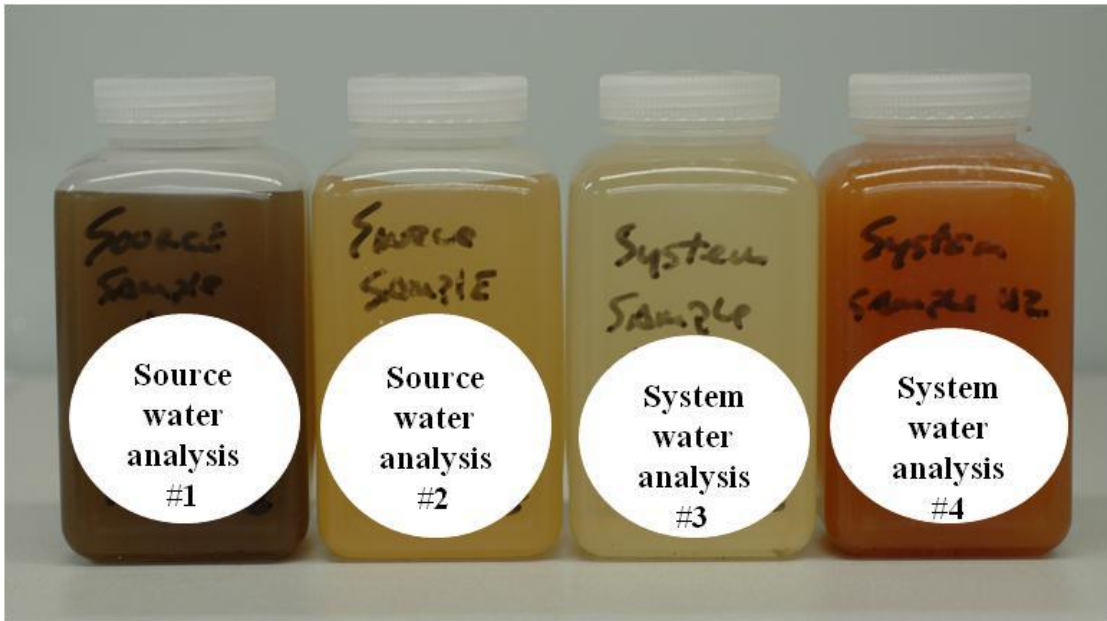
Figure 5.9 shows four water samples in a wet pipe system. Source water analysis samples #1 and #2 are source water samples, while system water analysis samples #3 and #4 are system water samples. The two source water samples are brown and light tan, and the two system water samples are yellow and reddish-brown. This facility's wet pipe fire protection system was 4-5 years old after showing pipe leakage. Two feeder line pipe samples, and two source and two sprinkler system water samples, were received for analysis. Results of water chemistry and SRB analysis are shown in Table 5.2.

The immunoassay sulfate reducing bacteria analysis of the sprinkler water samples showed that the concentration of SRB was negative (below the test's detection limit - 10^3 cells/ml), i.e., $< 10^3$ SRB bacteria were present in each 1 ml of water. Consistent with these findings, the results of the lead acetate sulfide analyses of both the sprinkler and source water samples were negative. There was also no significant reduction observed in the sulfate concentration in the sprinkler waters compared with the source waters. These results indicated that planktonic SRB concentration was below detectable limit.

Figure 5.9 Photograph showing the four water samples in a wet pipe system. samples #1 and #2 are source water samples, while samples #3 and #4 are system water samples.

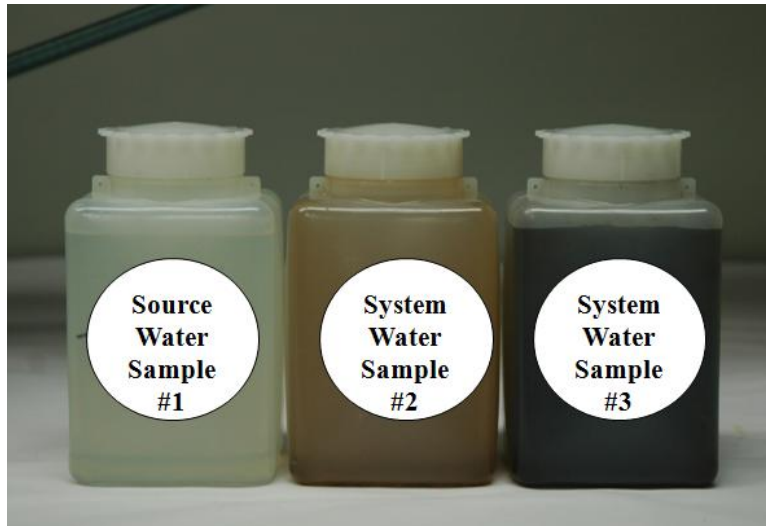
Figure 5.11 shows three water samples in a wet pipe system. Source water analysis sample #1 is the source water sample, while system water analysis samples #2 and #3 are system water samples from the 2-inch drain and the inspector test connection, respectively. This wet pipe system was over 12 years old, and no leakage had been reported in the system.

Figure 5.11 Photograph showing the three water samples in a wet pipe system. Sample #1 is from source water. Samples #2 and #3 are system water samples.

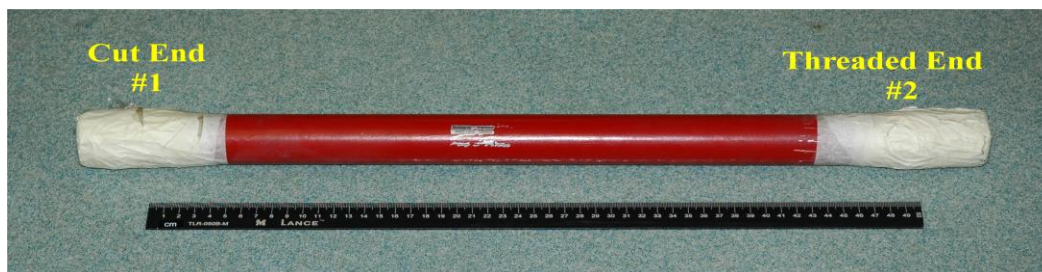
Figure 5.12 is a photograph showing an NPS 1¼ branch line pipe removed from the system. Visual examination of the inside diameter surfaces of the pipe revealed that it was in relatively good

Figure 5.12 Photograph showing an NPS 1¼ branch line pipe sample.

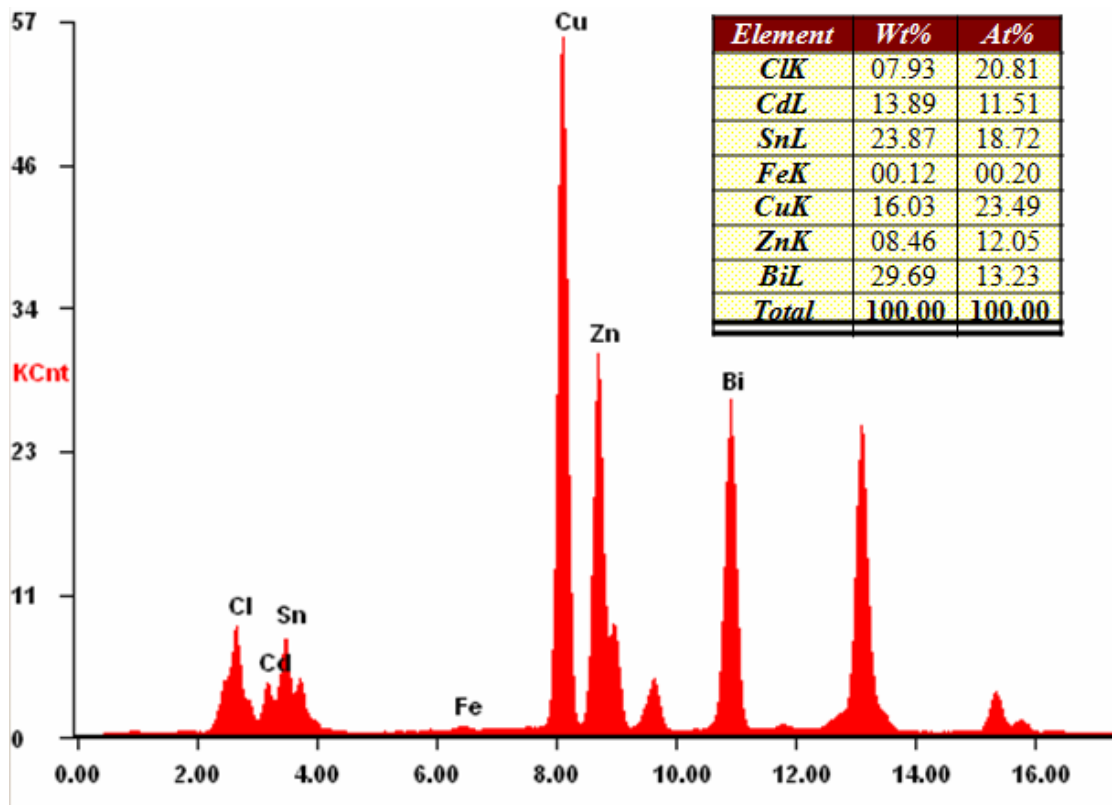
Figure 5.14 is the Xray microfluorescence spectrum of the bluish-green corrosion products/deposit buildup area circled (red) in Figure 5.15 and its standardless (semi)quantitative chemical analysis results of the XRMF spectrum. The Cu, Zn and Fe spectrum peaks in Figure 5.16 are associated with brass sprinkler compositions; the Bi, Sn and Cd peaks are from the fusible solder. The Zn and Cl spectrum peaks are related to the presence of a zinc chloride flux residue on the fusible solder.

In summary, the cause of the failure of the sprinkler head was the combined effects of the presence of trapped flux within the soldered joint, as well as the penetration of environmental gases and moisture into the joint that caused corrosion of the fusible solder. These preexisting

and in-service deterioration conditions weakened the joint, which ultimately led to its separation due to time-dependent creep.

Figure 5.16 X-ray microfluorescence spectrum of the bluish-green corrosion products/deposit buildup area circled (red) in Figure 5.15 and its standardless (semi)quantitative chemical analysis results of the XRMF spectrum.

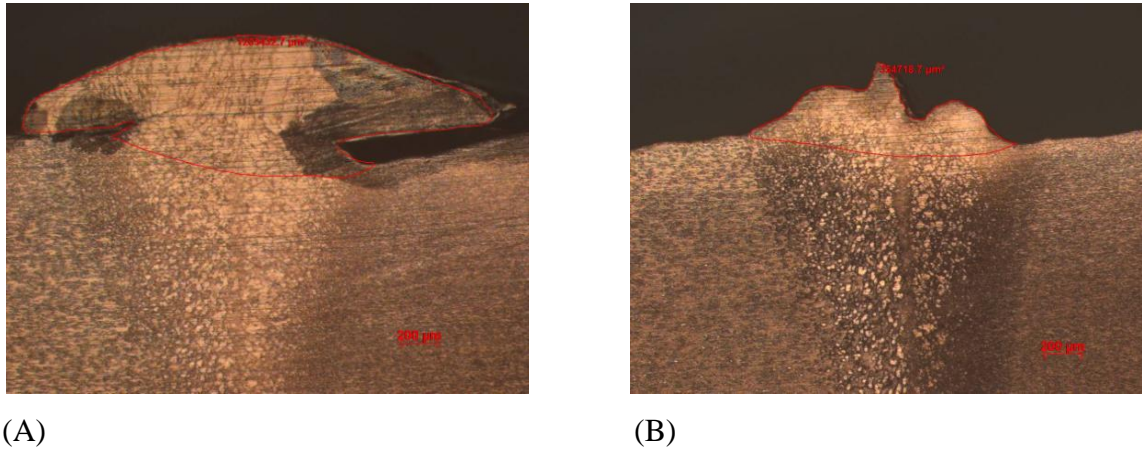
Figure 6.1 shows metallographic images of weld protrusion of pipe sections oriented in the (A) 9 o'clock (side) and at (B) 6 o'clock (bottom) directions after 12 months of exposure in aerated artificial sea water.⁶³ After 12 months of dynamic testing, the corrosion (metal loss) of the weld

located at the 6 o'clock (bottom) position is 2.7 times higher than that of the weld located at the 9 o'clock (side) position (77.7% vs. 29.1 %).⁶³

Figure 6.1 Metallographic images showing weld protrusion of pipe sections oriented at the (A) 9 o'clock and (B) 6 o'clock position (50X magnification).

To mitigate pipe weld corrosion in fire protection systems, it is recommended to: (A) orient the pipe weld seam above the 9 o'clock position (side) toward the building roof, to prevent the weld seam from being located at the 6 o'clock position (bottom) and to reduce pipe weld corrosion rate of electric-resistance welded steel pipe; (B) select steel sprinkler pipe without irregularly shaped finger-type pipe weld for better corrosion resistance of the weld seam area; and (C) reduce the frequency of introducing oxygen-rich water into the steel sprinkler piping system (e.g., periodic inspector testing) to decrease the corrosion rate of the steel.

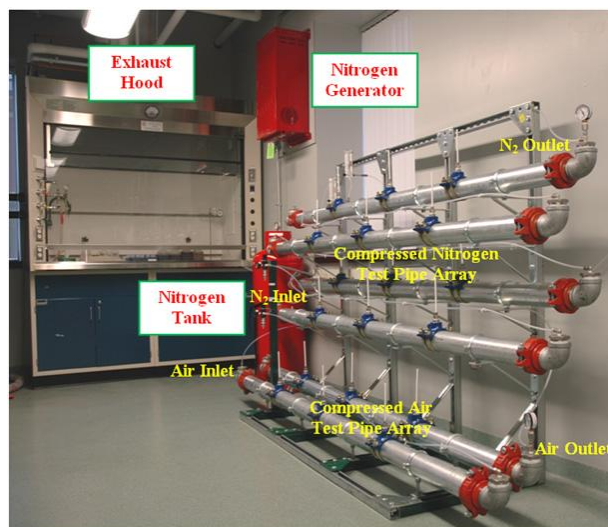
Figure 6.2 Photograph showing an overall view of the compressed nitrogen corrosion test apparatus.

Figure 6.2 is a photograph showing an overall view of a corrosion test apparatus with pressurized nitrogen and compressed air (house air) at 40 psi (0.28 MPa) and 0.2 L/min. flow rate in the pipe test racks.⁶⁷ Initially, a test rack was designed and assembled to support the six pipes containing the test coupons. The other major components that comprise this apparatus – namely, the nitrogen generator, the nitrogen receiver (storage tank), the pipe test rack containing the compressed nitrogen pipe array (top four pipe rows), and the exhaust hood – have been highlighted. The bottom two pipes visible in Figure 6.2 comprise the compressed air test pipe array, which is fed by compressed air available to the laboratory.⁶⁷

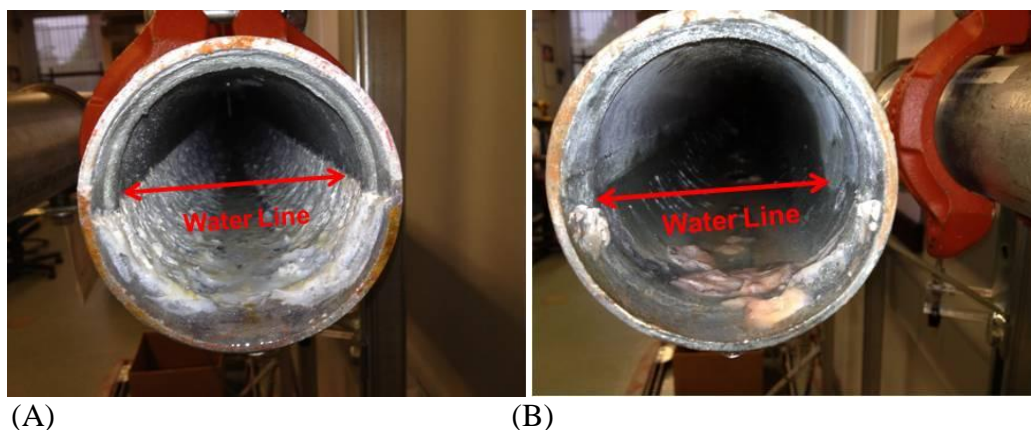
Figure 6.3 (A) and (B) shows photographs of galvanized steel pipe half-filled with tap water in (A) house air and in (B) compressed nitrogen, after nearly 6 weeks exposure. For comparison, whitish zinc corrosion products covered the bottom half of the house air-filled pipe in Figure 6.3 (A); yet, only limited zinc corrosion products covered bottom half of the compressed nitrogen-filled pipe in Figure 6.3 (B). This indicated that compressed nitrogen can reduce corrosion of galvanized steel pipe containing trapped water.^{67,68}

Figure 6.3 Photographs showing galvanized steel pipe half-filled with tap water in (A) house air and in (B) compressed nitrogen for nearly 6 weeks.

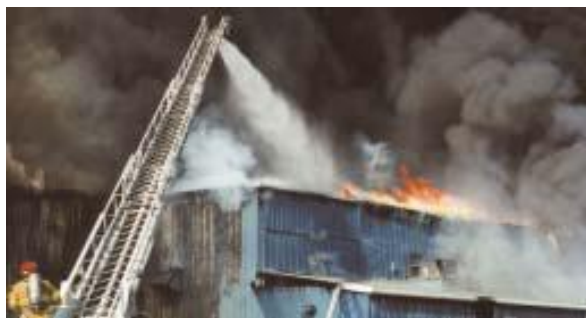
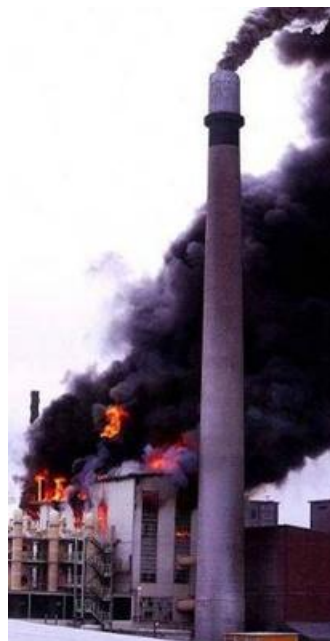
Figure 6.4 Photographs of fire incidents. (A) An unsprinklered steel pickling facility with plastic ductwork system, and (B) An unsprinklered facility with corrosive environment.

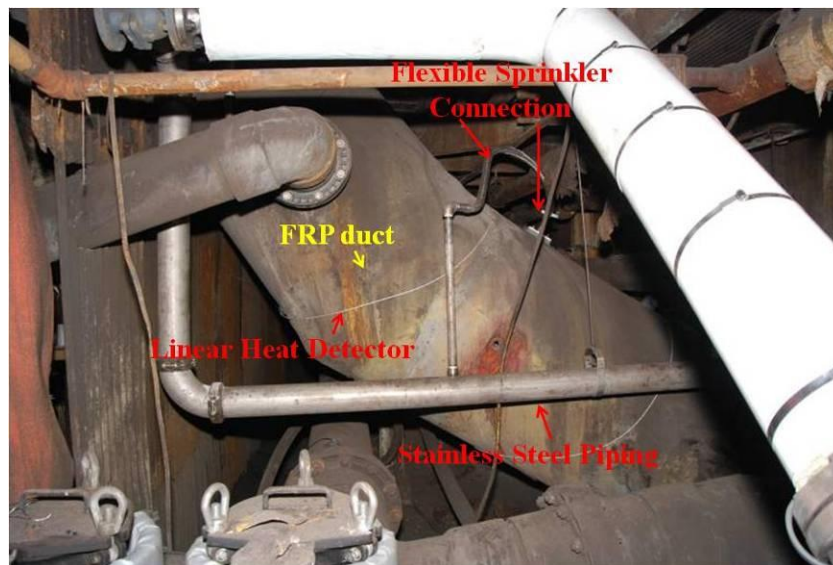
A fire protection system in the FRP exhaust duct of an HF/HNO₃ steel pickling line has been developed for field application as shown in Figure 6.5.⁷⁹ This new fire protection system is designed to protect FRP or other combustible plastic ducts with corrosive atmospheres. This system is comprised of corrosion-resistant sprinkler nozzles (see Figure 6.6),⁸⁰ linear heat detector (LHD) wires and fire control panel, flexible sprinkler connections, plus other accessories. It is designed to be suitable to protect combustible exhaust ducts from fires in extremely corrosive environments, such as high concentrations of H₂SO₄, HCl, HNO₃, and HF acids, as well as smoke.⁷⁹

Figure 6.5 Representative photograph showing part of the fire protection system protecting the main FRP exhaust duct.

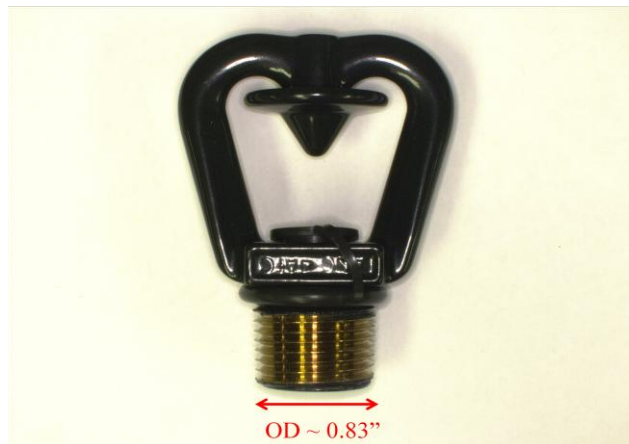
Figure 6.6 Photograph showing a corrosion-resistant nozzle with ethylene chlorotrifluoroethylene (ECTFE) coating, rounded deflector, and Teflon-based plug.
